Full Survey S/Y SeaQuell

YOUR YACHT SURVEYOR by YOUR YACHT GROUP

Survey: Marina Vela - E/M/V Badalona (Catalunya - Spain) Date of Survey: 23th of May 2025

Pre-Purchase Inspection

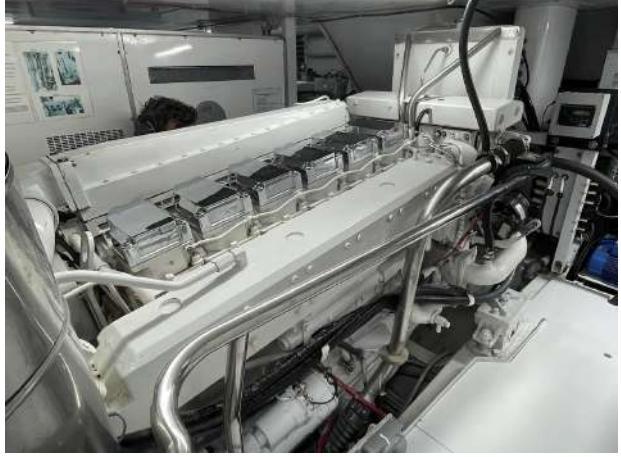
Main Engine

Fuel pre-filter	Ν	Working correctly while running on sea trials.
Water filter	Ν	The system performed correctly during sea trials.
Engine paint	-	Looking fair. It can be noticed some touch-ups. Please check "Invicta Engineering" official engine report - attached in the annexes.
Engine corrosion	-	There is no corrosion. Please check "Invicta Engineering" official engine report - attached in the annexes.
Electrical installation engine	Ν	With any relevant modification to the report.
Batteries	Ν	Working well, in a well-fixed area with the cabling system maintained.
Battery charger	Ν	Working well. Tested with shore power.
Autopilot	Ν	Tested during the sea trials, the system was working correctly, with a normal time response.
Steering system	Ν	The connection to the rudder was found in good condition.
Safety Equipment	_	Regarding safety equipment, it should be noted that a full inspection was not conducted, as the requirements are dependent on the flag state regulations. Liferafts, fire extinguishers, and lifejackets were found in place during the inspection.

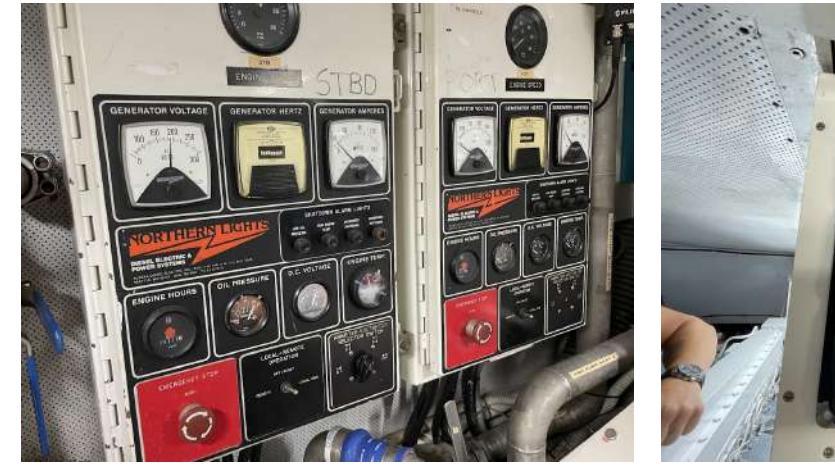
Generators panels

Gas bottle locker	-	Not inspected.
Generators	_	The yacht is equipped with two Generators. Both were tested during sea trials. Both are the same model and run well. Generator maintenance is to be scheduled as part of the general yearly maintenance.
Electrical installation onboard	A	No relevant modifications were observed. The 120v and 24v panels are clearly labelled, and all switches are functioning as expected. The voltage indicators are operating correctly.
Electrical panel	Ν	Found with no modifications to report. The breakers are working well.

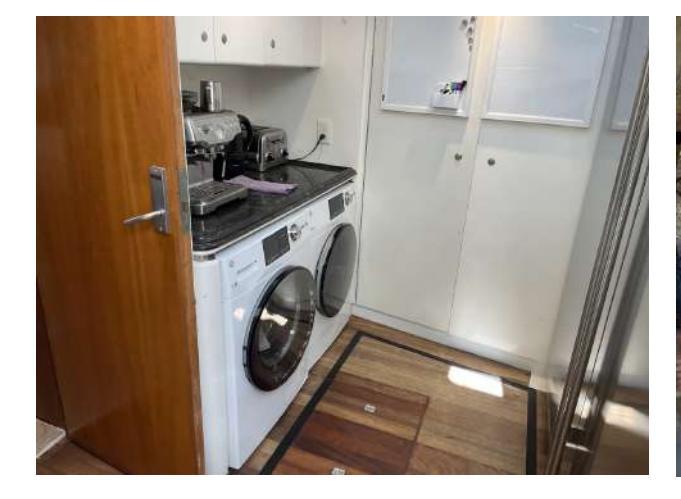
On the aesthetic aspect, it looks well-maintained and clean.
Tender Crane	-	The yacht has a tender crane integrated into the forward area. It allows launching the tender quickly. It was not tested during the sea trials.
Thermal Camera	Ν	The mast is equipped with a thermal camera, securely fixed on the forward area of the mast. This enables continuous monitoring of the sea during navigation, irrespective of conditions. The camera's imagery is displayed on the interior screen of the captain's area. The FLIR camera functions correctly.
Laundry equipment	-	The yacht is equipped with washing and drying machines. Both are integrated into the galley. They were not tested.

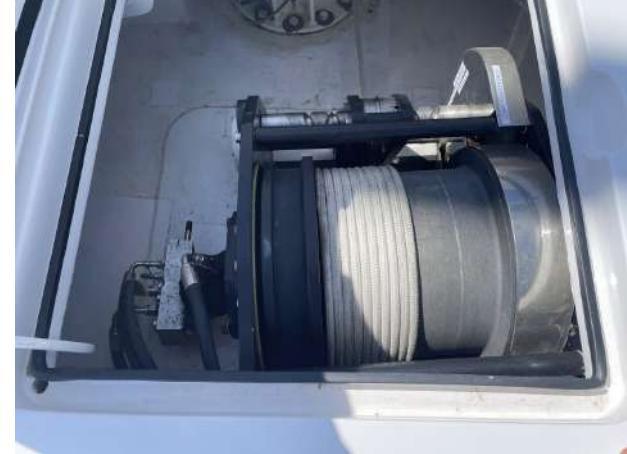
Furling the main sail

Sails	A	According to information provided by the owner, the vessel is equipped, at least, with the following sails: - Storm jib - Battened mainsail - Furling mainsail - In boom - Gennaker/Cruising Spinnaker - Genoa - Furling Genoa However, during the sea trials, only the mainsail and genoa were observed. Both sails were clean with no issues to report.
Main Sail	A	Looking in good condition. Fully deployed easily by its winch system. During the manoeuvre, the crew greased the sliding-in-rail area of the sail. It is a furling main sail (inside the boom).
Genova Sail	A	Also looking good. Fully deployed from the captain's position.
Genova rigging	A	All the rigging, such as lines, rings, or SS elements, is found in good condition.
Stoppers - rope clutch	Ν	The line stoppers, primarily situated below the deck (inside the rigging hatches), functioned as intended; however, a degree of force was required for their actuation. System inspection as part of routine maintenance may be warranted.

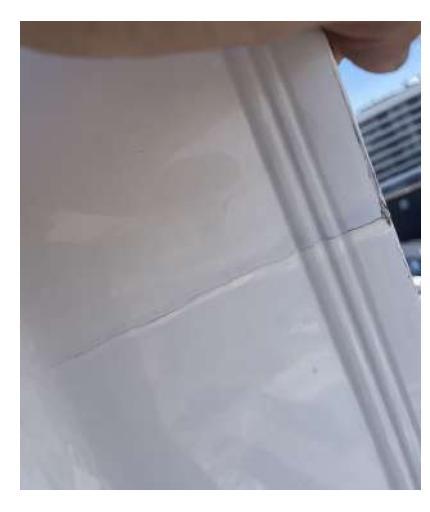
Mast detail

Area	Defect	Comments
Mast	A	The mast exhibits minor scratches and no significant corrosion. The mainsail lines are correctly positioned. All equipment attached to the mast, including tracks, lights, electronics, and stainless steel fittings, presents no evidence of corrosion or damage. Full rigging service during the 2023 refit. Important Note: During the mast ascent, a union of the mast sling rail exhibited evidence of corrosion and superficial damage. This is documented in the appended photographs (at the end 4.6). It needs to be monitored during the next seasons.
Boom	A	An inspection revealed no anomalies, damages, or defects. The boom is supported by a hydraulic ram situated at the mast base, facilitating tension release as necessary and enabling boom position adjustments. Furthermore, for sail stowage, a stainless steel fitting is installed at the boom end to secure its position (by using a custom-designed line & fitting) and prevent movement during navigation.

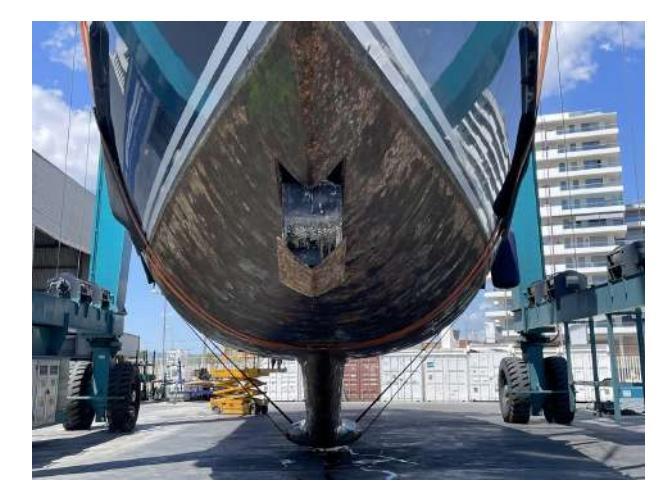
Area	Defects	Comments
Hull (underwater area)	R	The vessel's hull exhibited a condition indicative of insufficient recent cleaning. The last navigation occurred in September 2024. During the inspection, a quick cleaning of the hull was executed, with specific emphasis on the waterline and propulsion systems. Generally, no damage, signs of wear, or indentations were identified that necessitate reporting. Renewal of the antifouling scheme is required prior to the commencement of the season. It is recommended that a comprehensive cleaning be performed, followed by the application of two coats of antifouling protection.
Keel	R	The keel exhibited no damage or corrosion. It is a short keel with two small lateral wings. Additionally, the keel houses the shaft tunnel, allowing the propeller shaft to exit through the hull. No intermediate shaft bracket is installed, as the propeller is mounted directly at the shaft's exit point. Also it is required a full paint scheme renewal is required, as part of the underwater body hull.

Hull - before cleaning

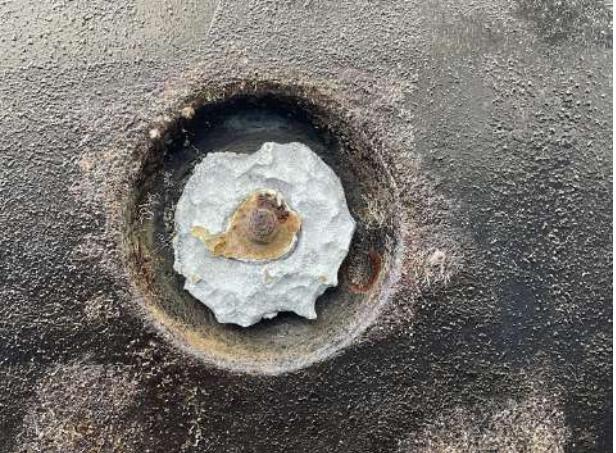
Annodes - to be renewed urgently

trials. The blades do not show any damage. The orientation of the propeller is tested during the sea trials, which worked correctly allowing the yacht to navigate as its optimal point of performance.
Anodes	R	To renew all of them.
Rudder	A	No movement detected on the rudder, which is well fixed in position. No data from the last shaft inspection.
Bow thurster	A	Prior to commencing the dry docking procedure, the bow thruster was deployed to facilitate a comprehensive inspection. No damage was detected on the propeller.
Aft thruster	A	The aft thruster is integrated into the yacht. It was completely blocked by seaweed. The cleaning revealed no signs of damage on the propeller. It does not have a protection grill.
Water intakes & outlets	A	They are found with no superficial corrosion and in good condition. The AACC intake and others were cleaned during the hull inspection, as they were found partially blocked.

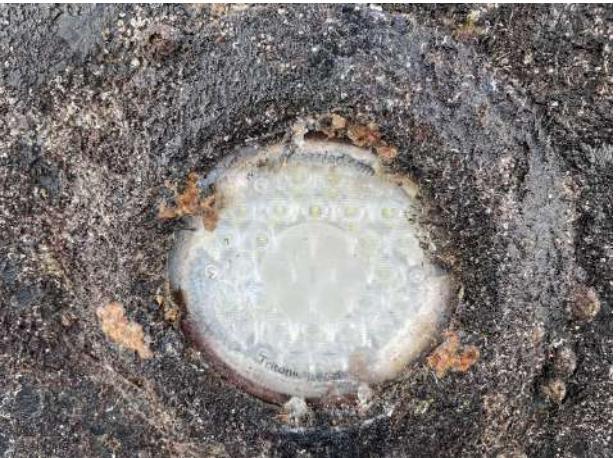
Underwater lights

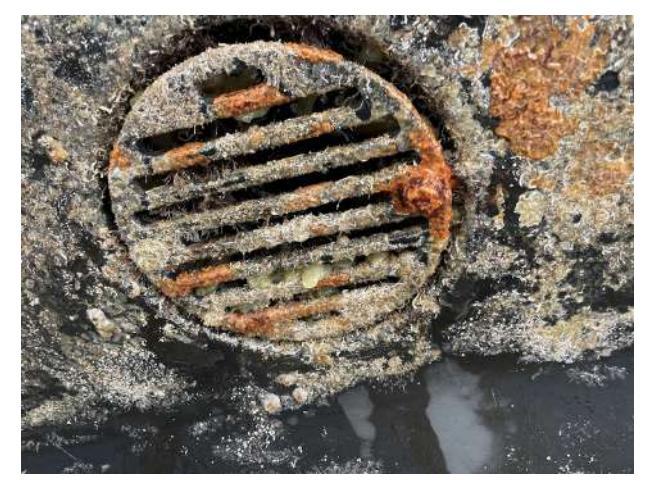
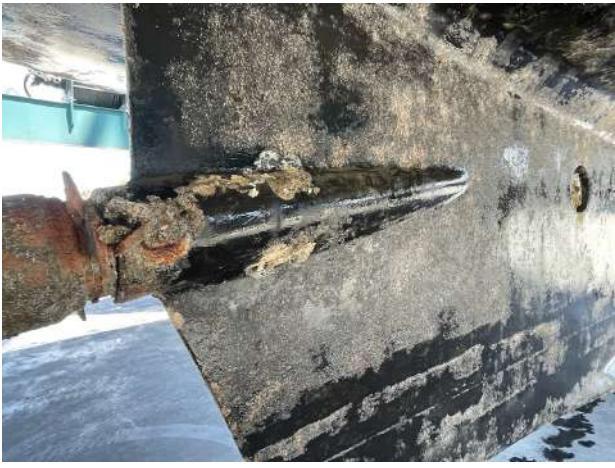
Hull grills

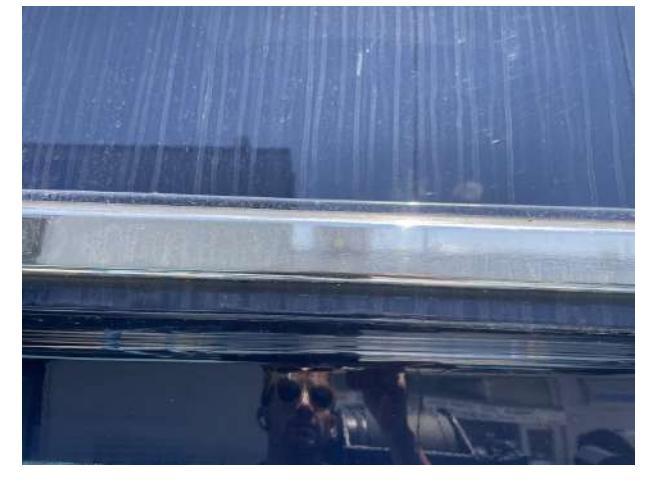
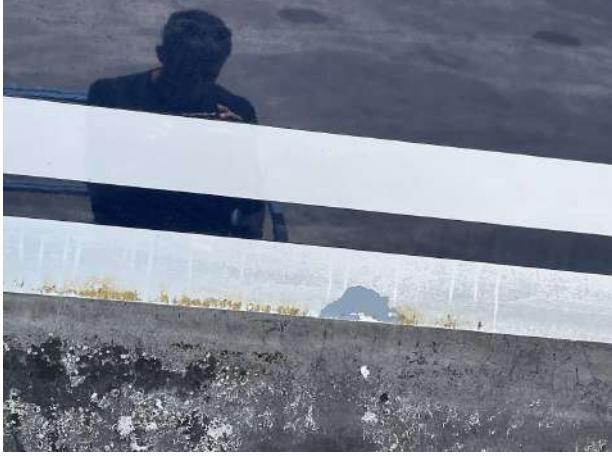
Rub rail

Waterline

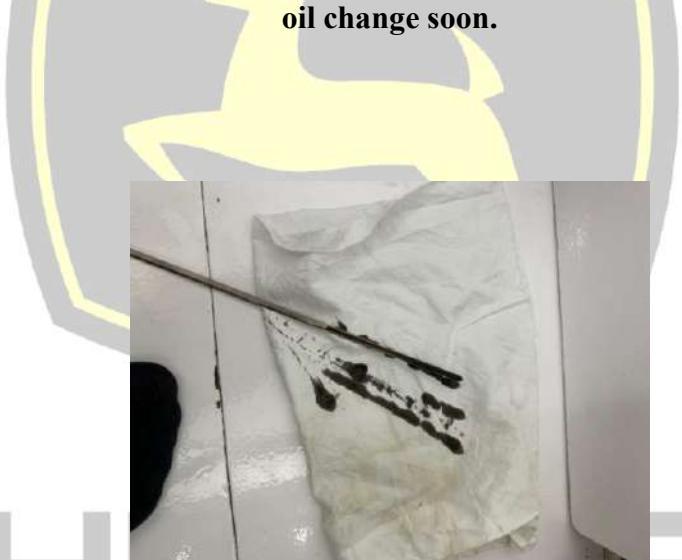
Engine oil checks. The oil level was correct and the oil Viscosity seemed ok without Oil sample checks only visual and feel test. They does seem some carbon content as you can see in the on the white cloth. Although normal I would recommend a engine

No metal file content could be seen or any hard materials found inside the oil from this visual check.

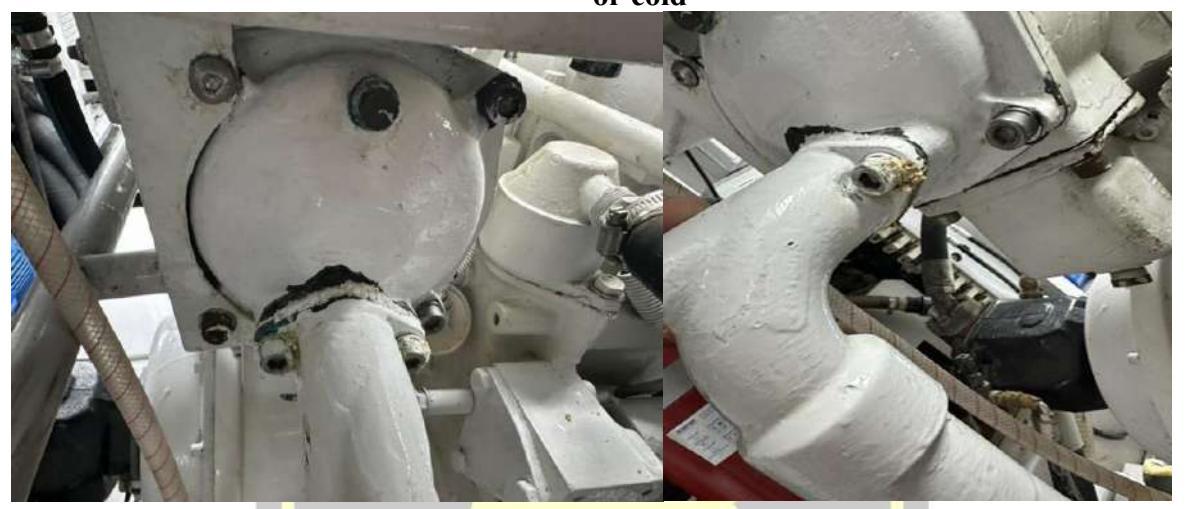
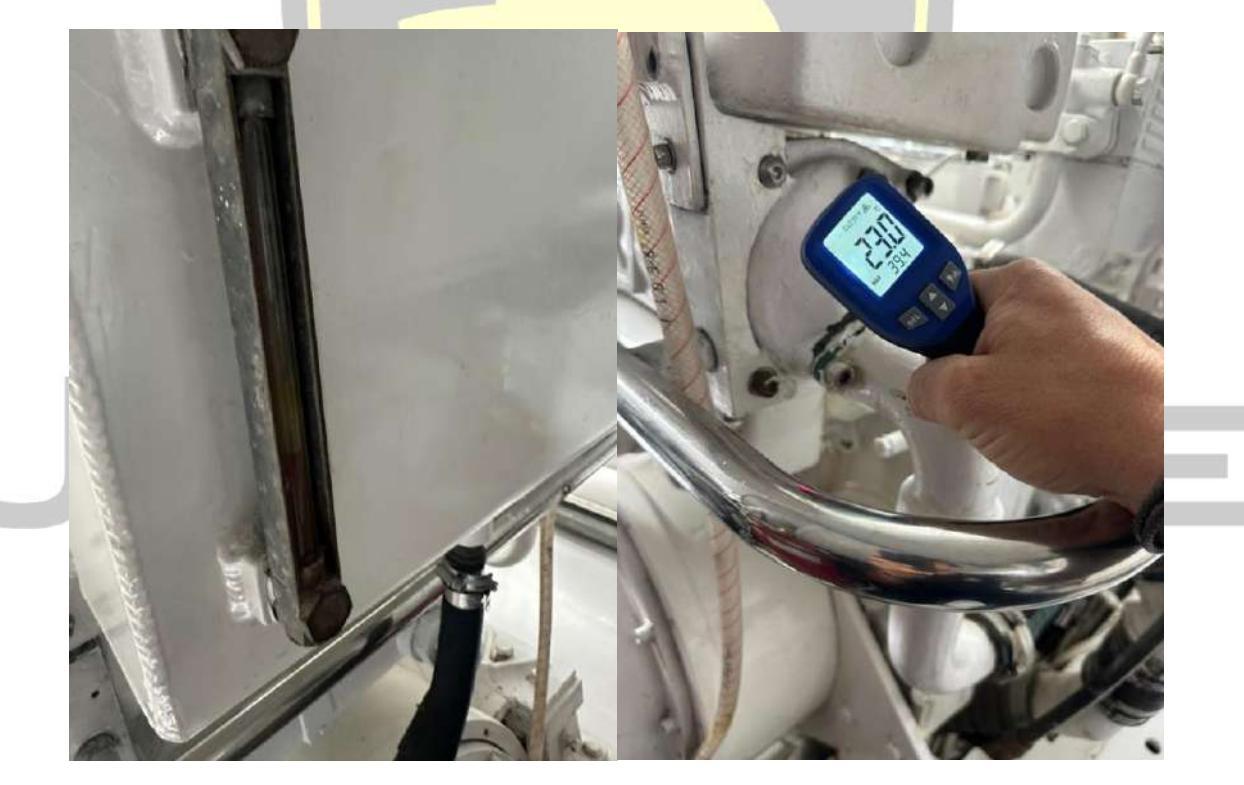
Engine sea water heat exchangers and coolers. Coolant level was correct and no signs of debris. Temperature was a good and consistent. No signs of overheating. Visual checks as you can see in the photos again the gaskets are perished and salt is protruding the connection. I would recommend anodes be checked and replaced. Heat exchangers removed, serviced and pressure tested. No visual leaks present hot or cold

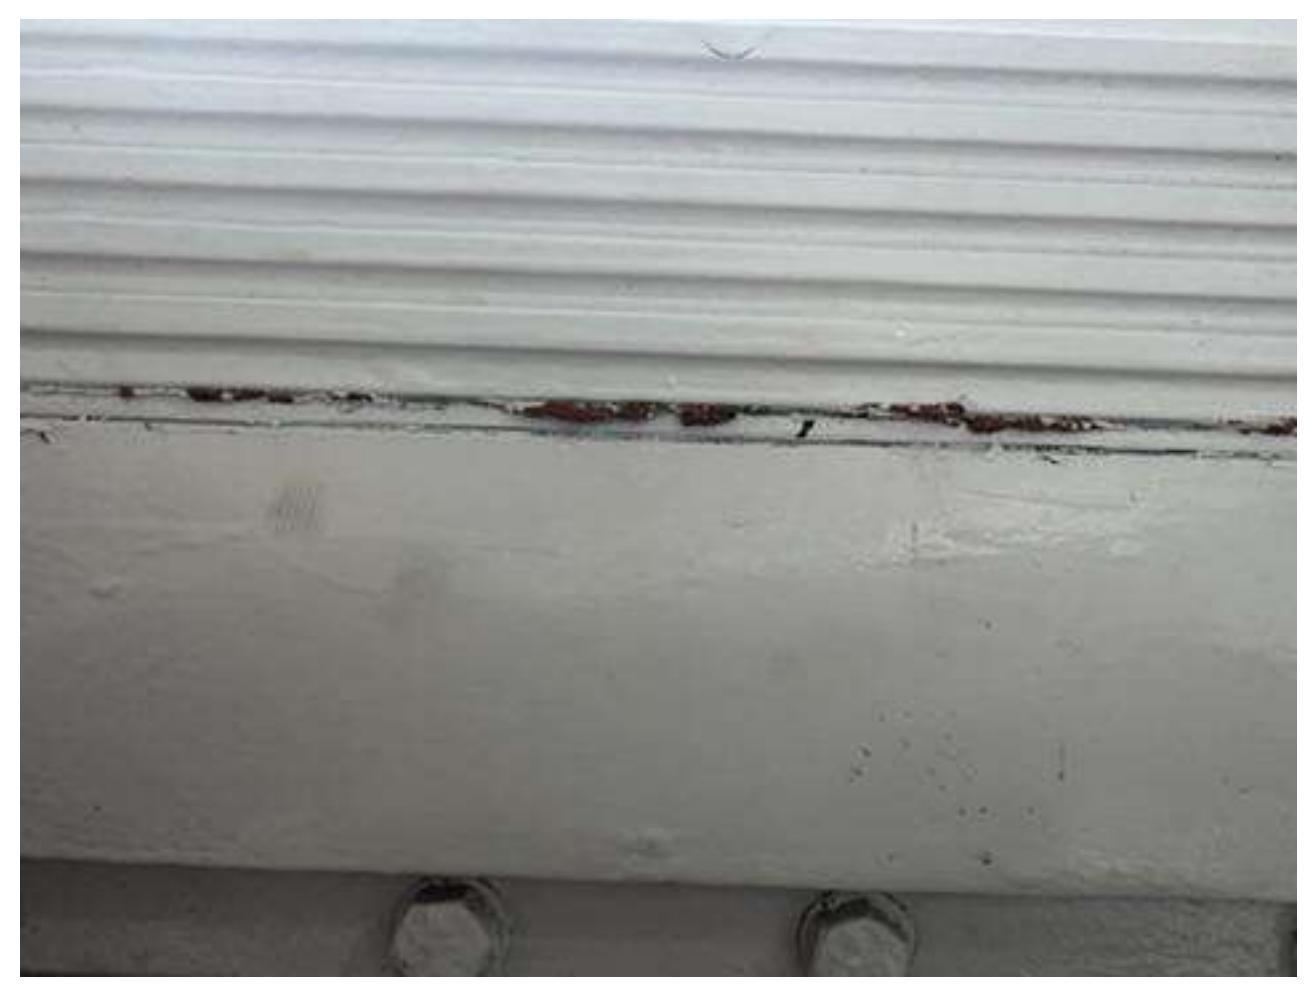
This is the gasket from the exhaust manifold cooler and would suggest it has been removed and service from the silicone gasket sealant used. Unsure if there is a original gasket present. No signs of any leaks.

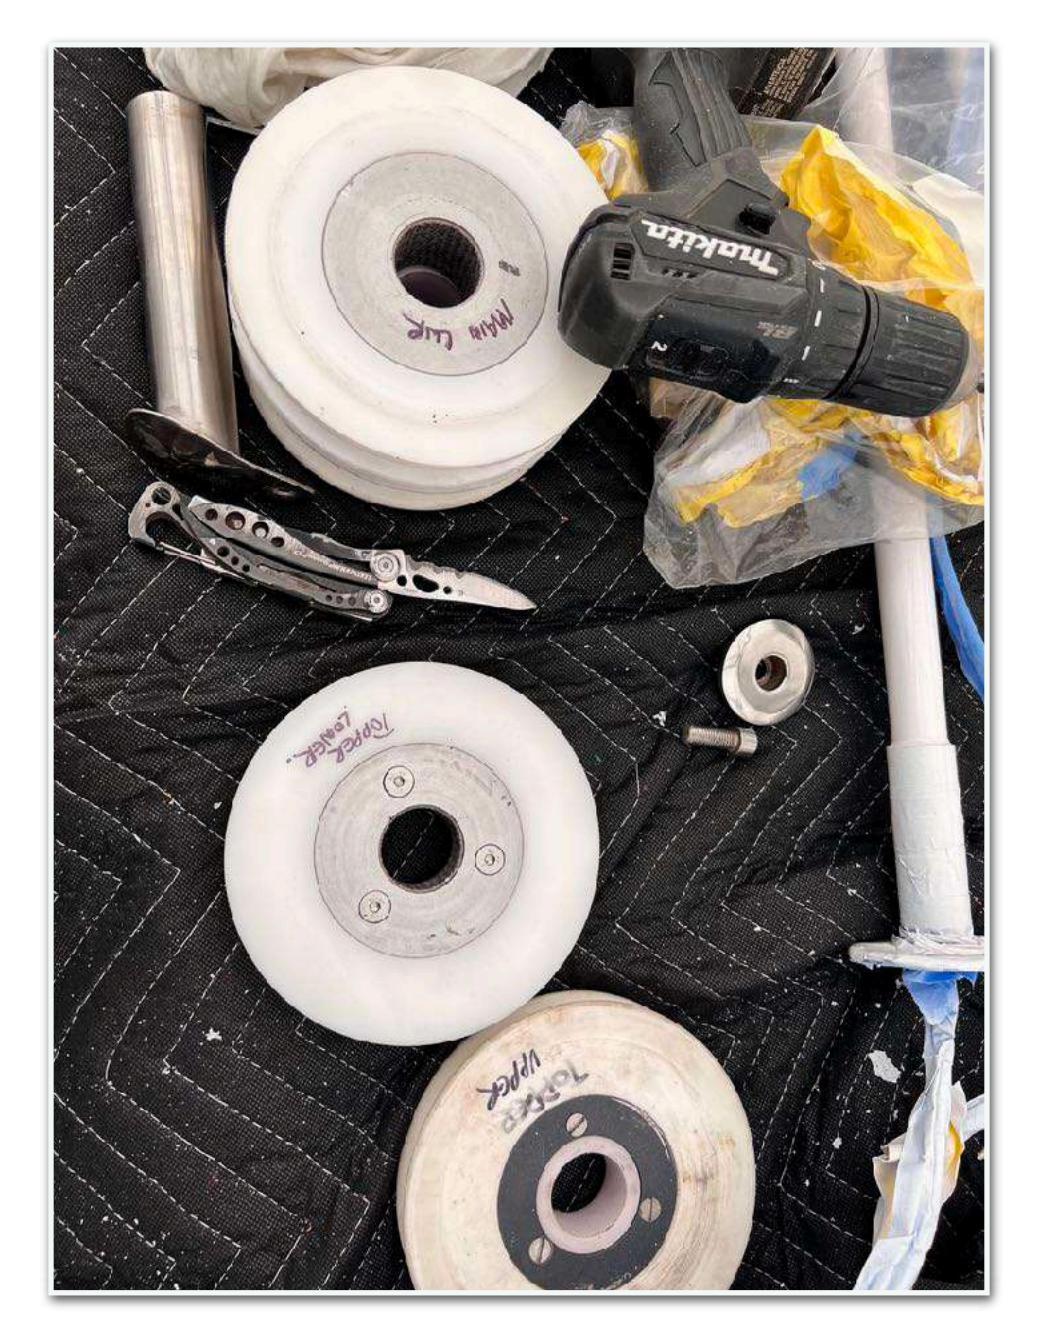
All sheaves in the mast were serviced with many needing new Dixon or Orkot bearings.

Vang tang needed new Dixon bushing.

The flying sheave to the masthead spinnaker halyard went missing during the course of the refit. This was ultimately replaced with an old style Lewmar snatch block that was locked in the closed position. This is actually now smaller than the original and more correctly sized for the job it does.

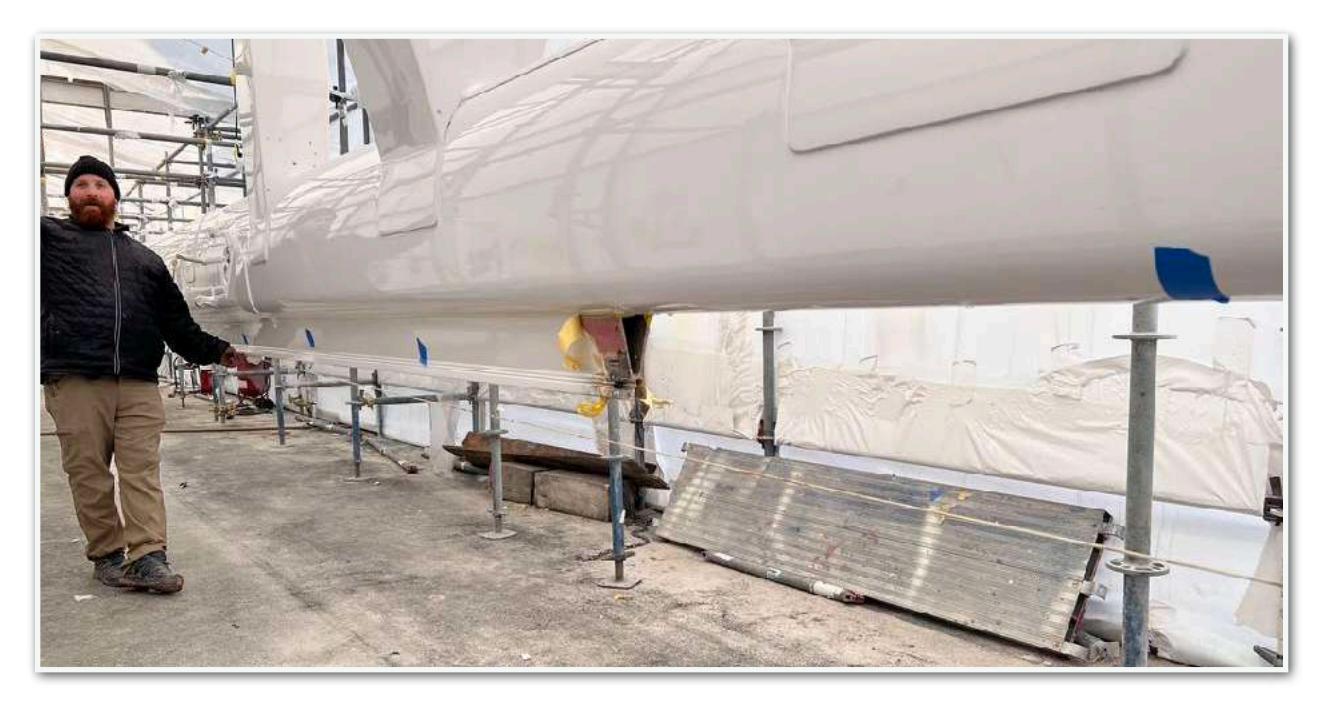
The lower extent of the mainsail track was extended aft, this involved cutting and wedging the track base profile to effectively make a ramp. This work was done with instruction from Shane the skipper at the time. As a result a new Flexi feeder base was constructed.
