Pre-Purchase Survey Inspection

Vessel Name
"MINE SET"

Prepared For:
Newcastle Marine Holdings LLC.

Conducted By:
Kerry Nikula AMS
SAMS AMS #1339 ABYC IAMI

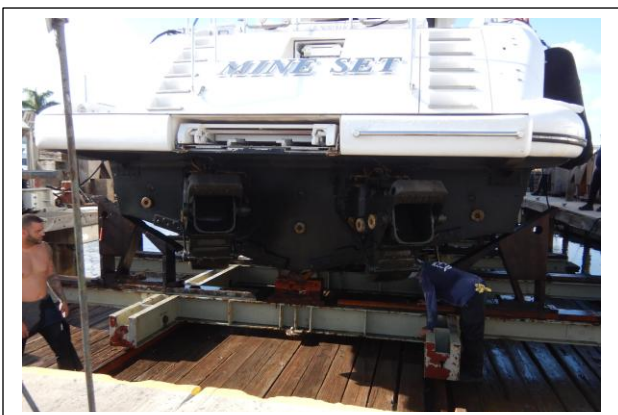
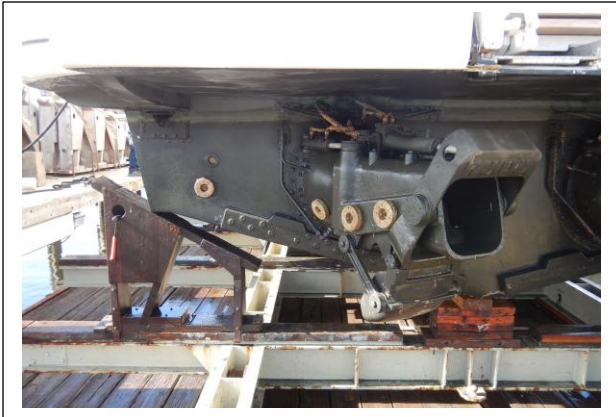
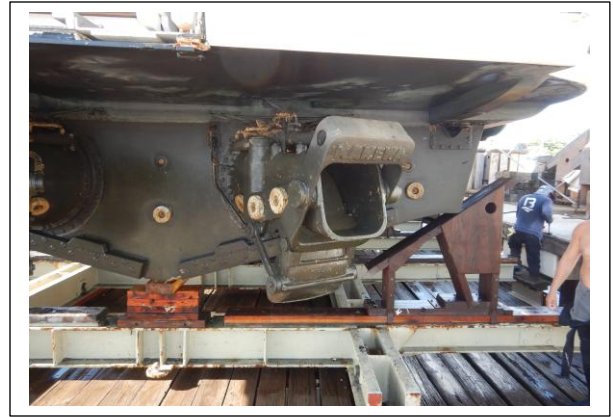
HAUL OUT

Condition of underwater areas: The vessel was taken for trial run after the inspection of underwater areas at time of haul out. The bottom was found to be "clean" with no significant marine growth noted on the antifouling coatings however marine growth was noted on the running gear.
