**UIN 081474C**

**Diesel Engine**

**Unit:**  
**Make**  
**Model**  
**Serial No.**  
**Site** Tom Hund Pacific Provider

**Name** Port Main Engine  
**Make**  
**Model**  
**Serial No.**  
**Capacity:**

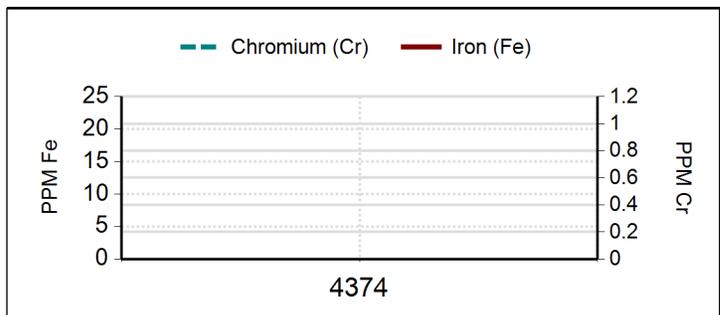
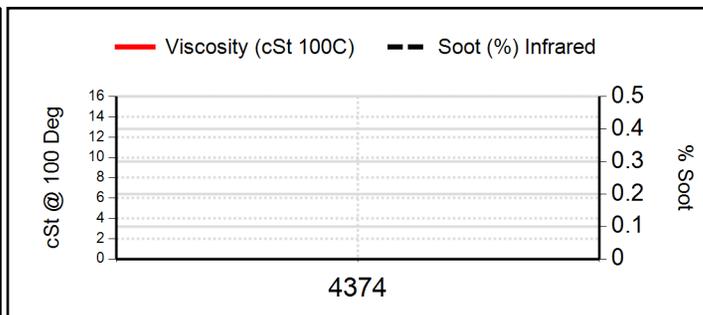
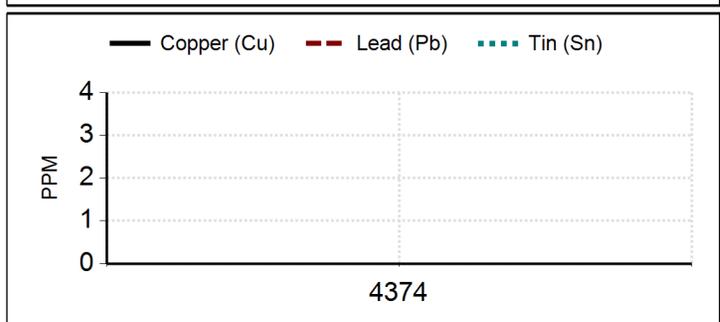
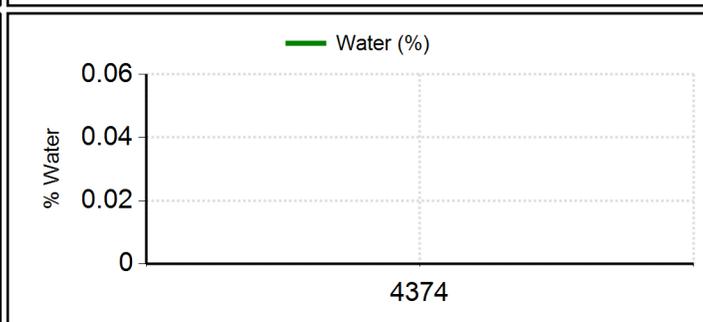
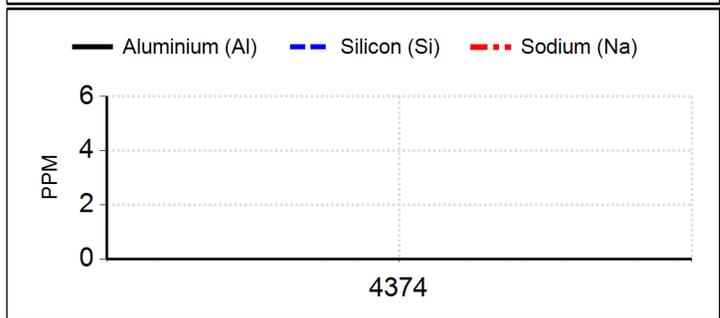
All wear levels appear within acceptable limits for first sample. Silicon level (dirt/sealant material) satisfactory. Water content acceptable. Fuel dilution satisfactory. Viscosity within specified operating range. Action: Resample at next recommended interval to monitor and establish wear trend.

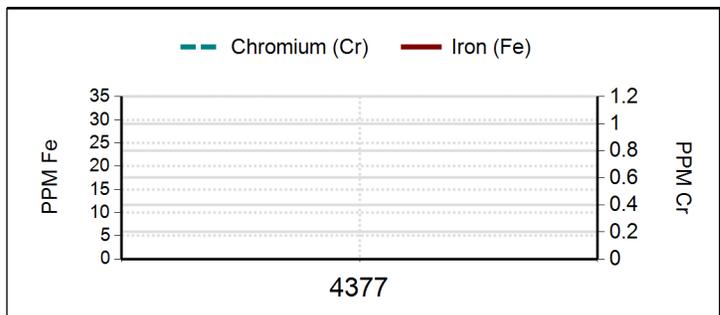
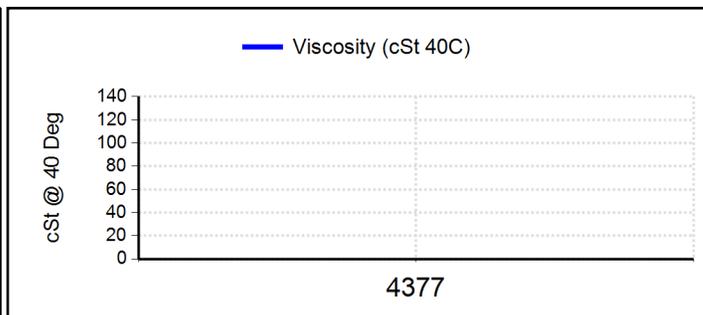
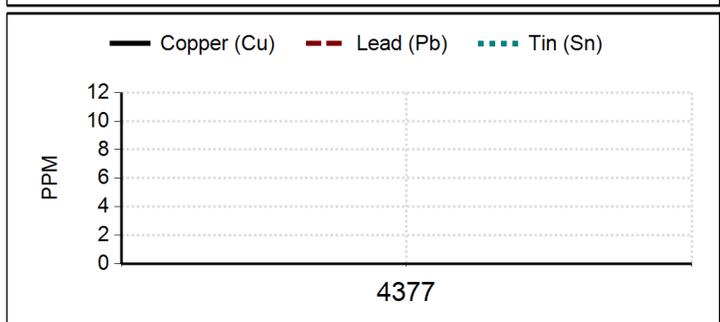
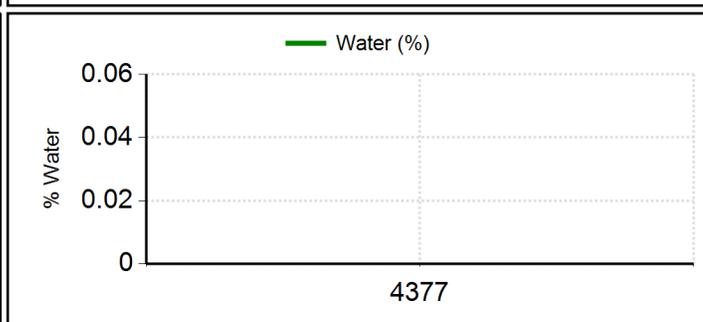
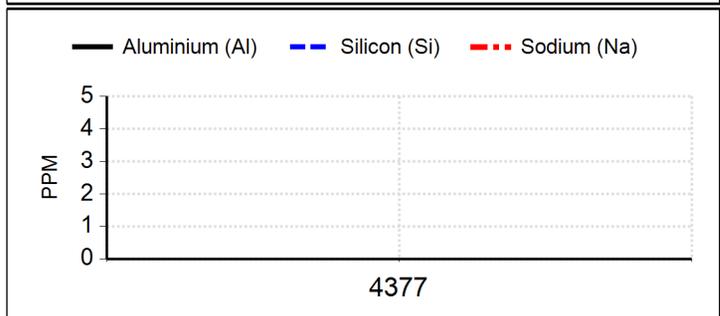
All wear levels appear within acceptable limits for first sample. Silicon level (dirt/sealant material) satisfactory. Water content acceptable. Viscosity within specified operating range. Action: Resample at next recommended interval to monitor and establish wear trend.

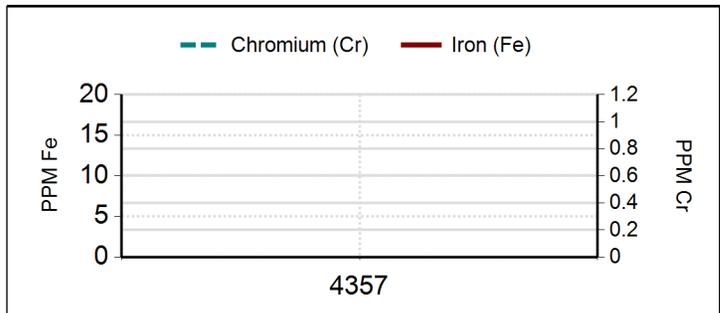
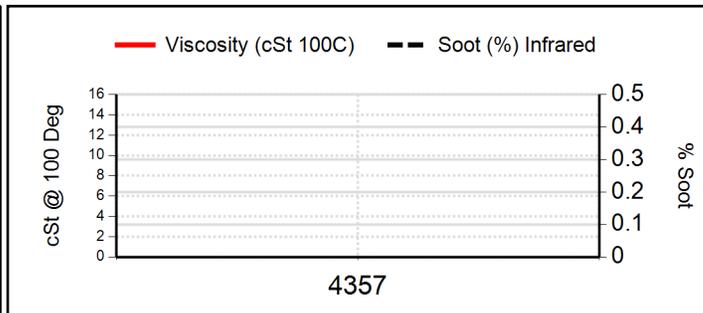
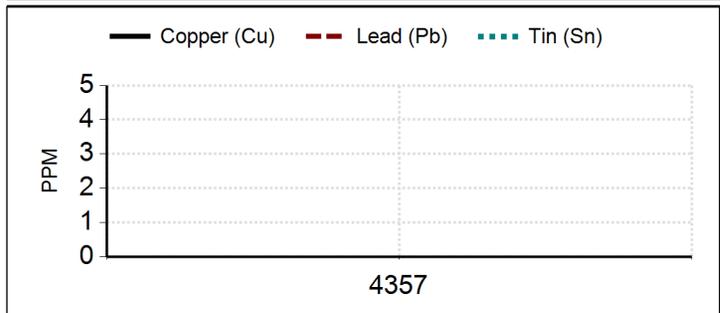
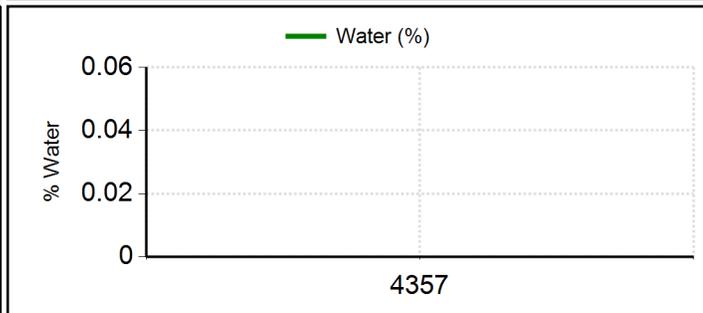
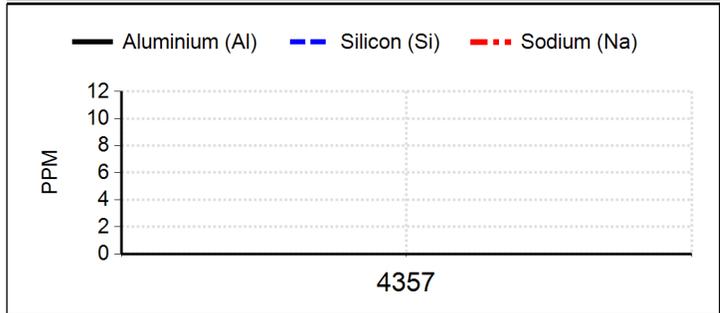
All wear levels appear within acceptable limits for first sample. Silicon level (dirt/sealant material) satisfactory. Water content acceptable. Fuel dilution satisfactory. Viscosity within specified operating range. Action: Resample at next recommended interval to monitor and establish wear trend.

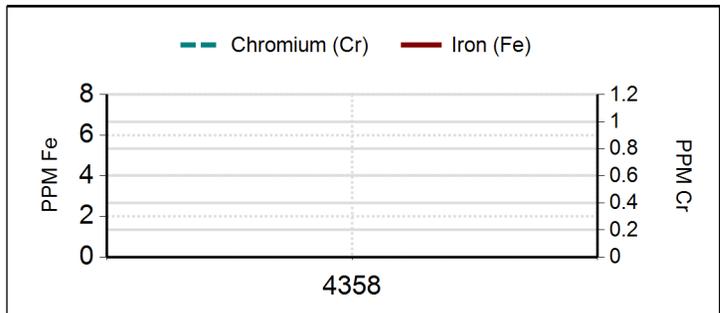
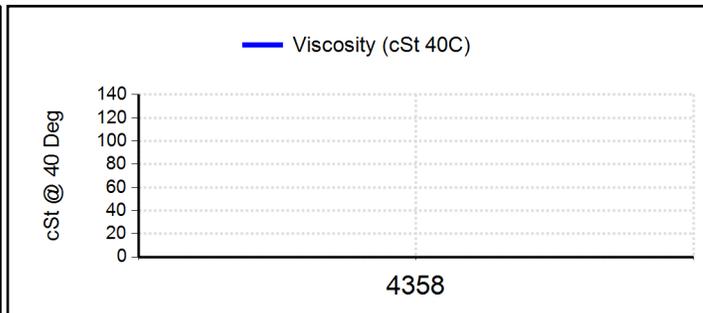
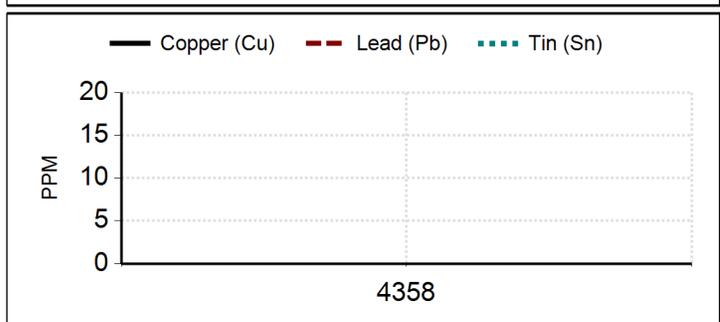
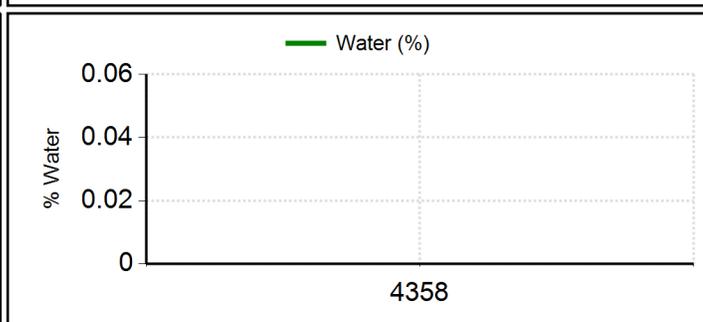
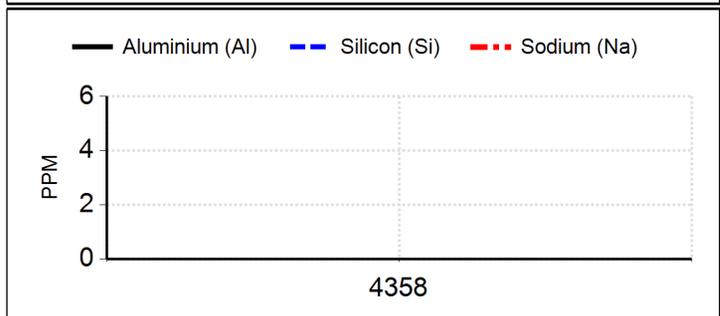
All wear levels appear within acceptable limits for first sample. Silicon level (dirt/sealant material) satisfactory. Water content acceptable. Viscosity within specified operating range. Action: Resample at next recommended interval to monitor and establish wear trend.
