**PATTON MARINE INC.  
SURVEYORS AND CONSULTANTS**

**October 10, 2026**  
**File No. : 14048-26**  
**Page 1 of 35**

**RE: "WELL DONE", 2000, 84', Burger Flybridge Motor Yacht**

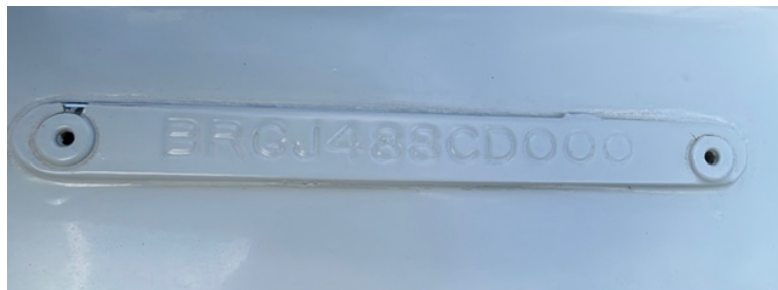
The hull is protected by upper and lower molded aluminum rub rails. Upper from the stern to forward of amidships. Lower from the stern to the stem.

No. of port lights: Port side: Five (5) rectangular opening type  
Starboard side: Five (5) rectangular opening type  
Hull color: White  
Boot stripe: Silver-White-Blue-White  
Name on transom: "WELL DONE"  
Hailing Port: Fort Lauderdale FL  
HIN: BRGJ488CD000

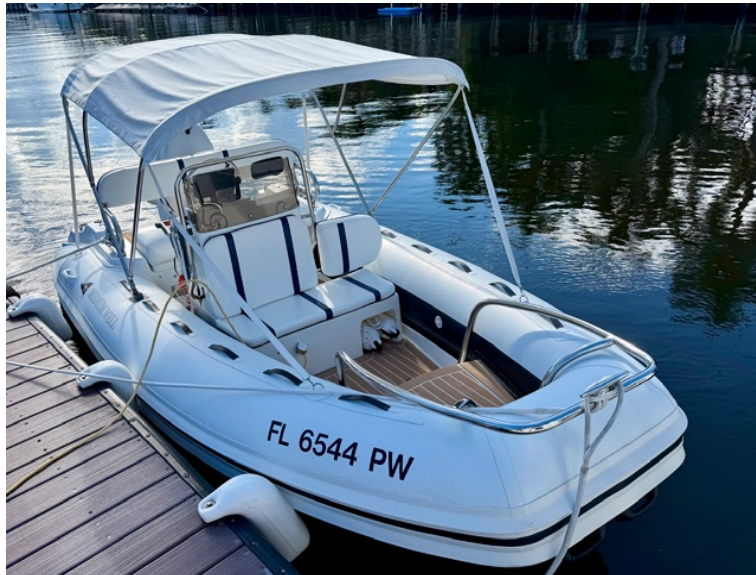
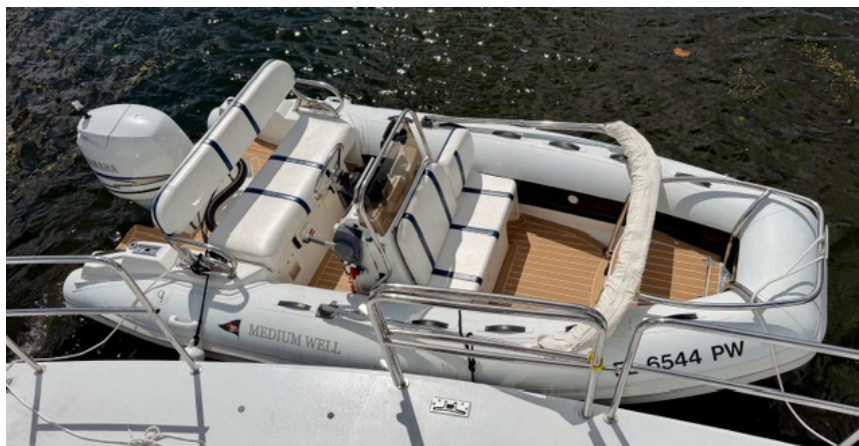
**Features:**

- Trim tabs,
- GPS Map & depth,
- VHF Radio,
- Nav Lights,
- Deck Laminate
