PATTON MARINE, INC.
SURVEYORS, CONSULTANTS & SUPERVISION
P. O. Box 451135
Miami, Florida 33245-1135

15 May 2020
File No. 12829-20
Page 1 of 18

RE: "ENTERPRISE"
1977 Sparkman & Stephens
Aluminum 12-Meter Sloop

This is a condition report for the purpose of an auction only and not to be used for other purposes. The following is a report of the findings.

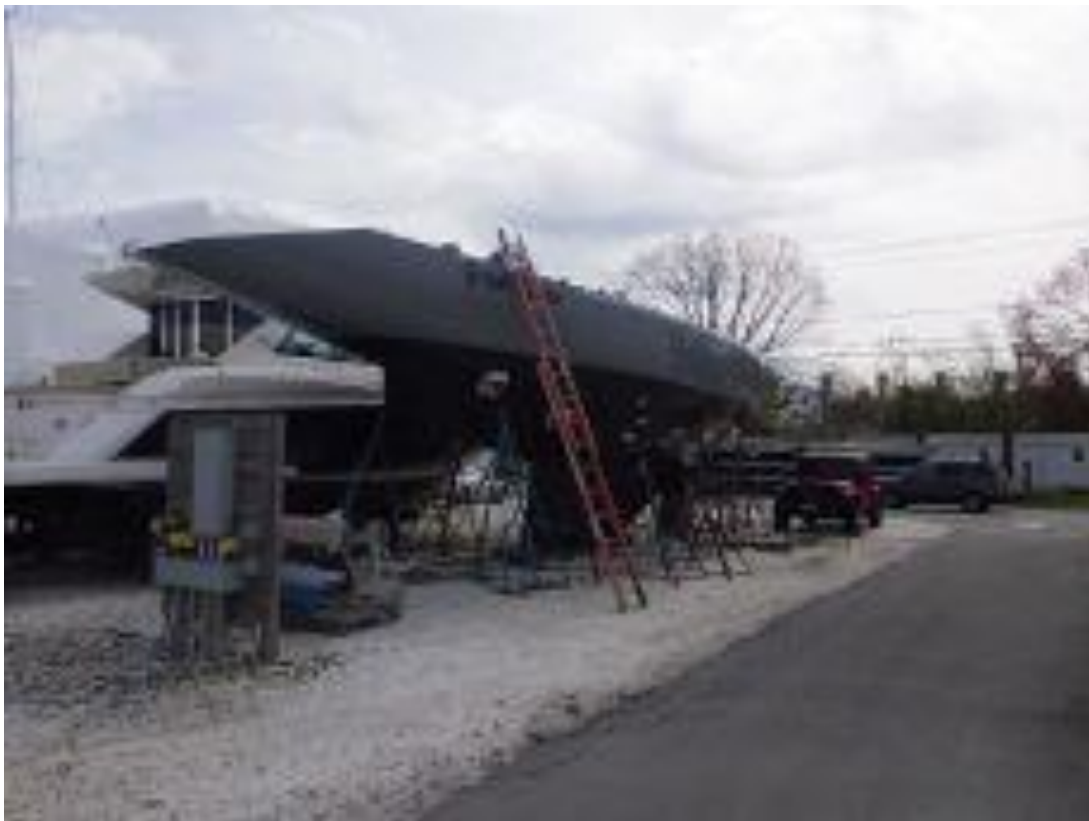
She is a traditional 12-meter (no winged keel) with raked bow, full keel with trim tab, balanced spade rudder and traditional overhanging transom. She has no engine and must be towed to and from the racecourse.

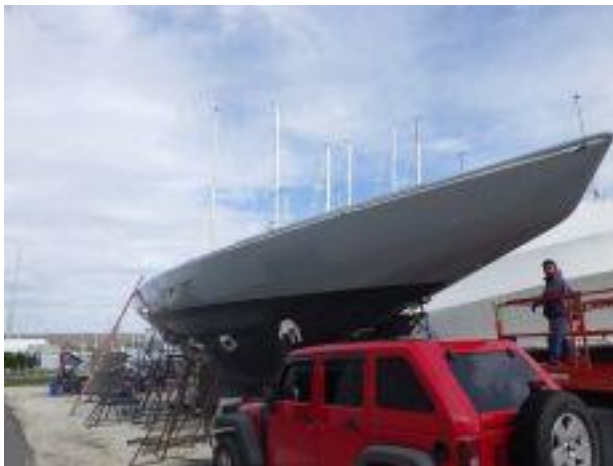
Starboard Hull

- The hull is very fair
- There are no signs of any cracking at the keel to hull join

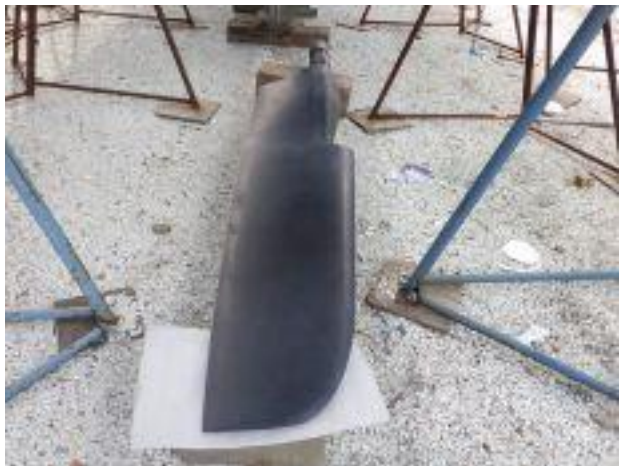
- Maker: Moore Brothers
- Carbon foil & stock – balanced – 5" dia. tapered stock – 11" X 79" deep
- Bushings on Stock – 2 X composite
- Bearing housings – JP3 aluminum in hull and deck
- Rudder seal – O-rings built into lower bearing
- Composite fairing flaps fitted
- Quadrant – Carbon fiber

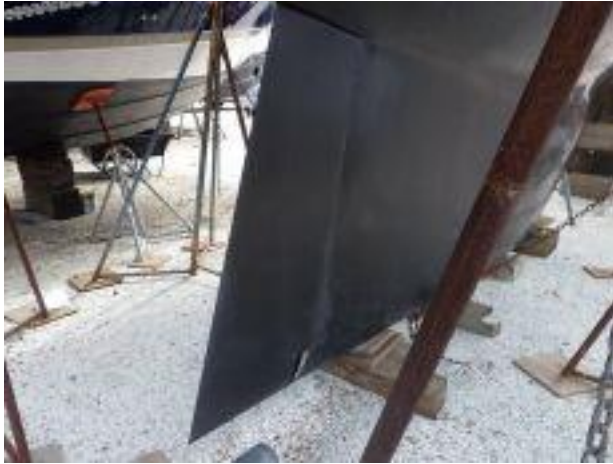
Trim Tab

- Aluminum – foil shaped – 3" stock
- Upper and lower pintle – gudgeon bearings to aft end keel
- 18" wide X 55" deep
- Seal – Not determined
- Quadrant - aluminum

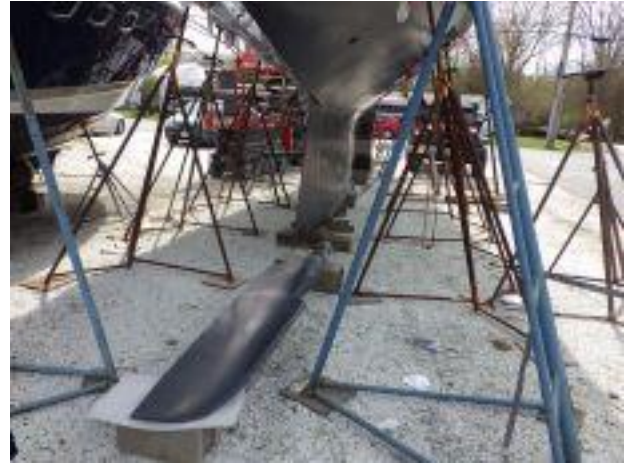
Keel from AFT

The keel is poured lead with 20 stainless steel keel bolts. Nuts are also stainless steel all accessible in the bilge. The keel is reportedly new in 2018 build by Bromfield & Son.

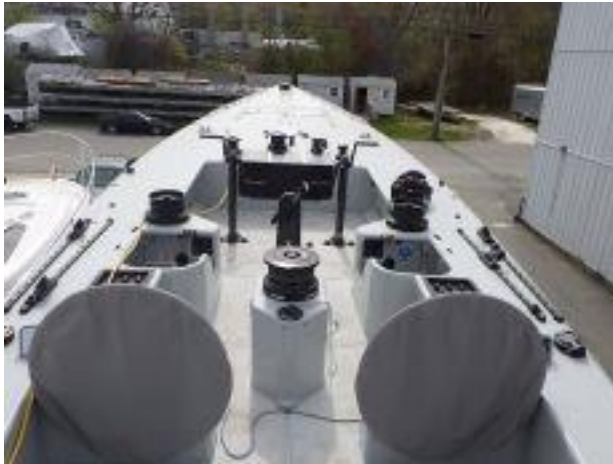
Main Deck from AFT

- Decks are flush with no camber and no lifelines
- Cockpit has a glued-on rubber non-skid
- Rest of deck is painted off-white
- Spinnaker pole trough on bow with freeing ports
- P & S 16' bolted on aluminum toe rails
- P & S sliding composite foredeck hatches

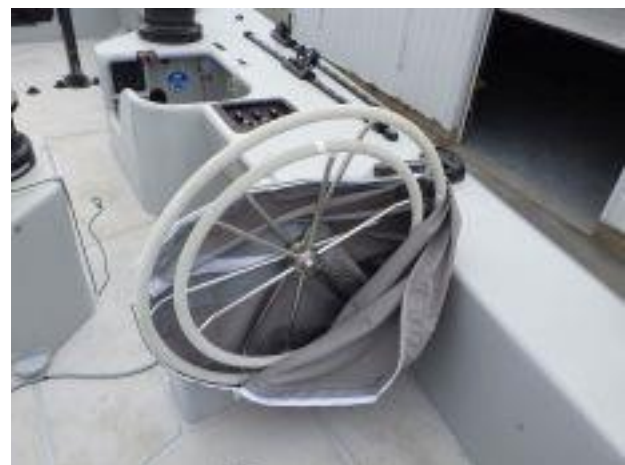
Steering & Trim Tab Wheels

- Manufacturer: EDSON
- Type: Chain and cable
- P & S stations each with twin SS 33" dia. & 27" dia. 6-spoke wheels
- Wheels can be linked with a clutch
- Trim tab – Aluminum quadrant with 3/16" dia. 7X19 SS cable
- Rudder – Carbon fiber quadrant with Vectren cable

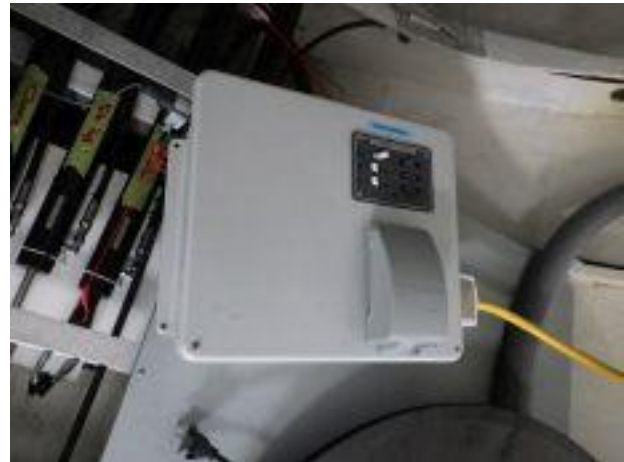
Shore power Junction box

- Shore power – portable box with 30-amp cord/inlet, breaker, and charger outlet
- Charger not sighted

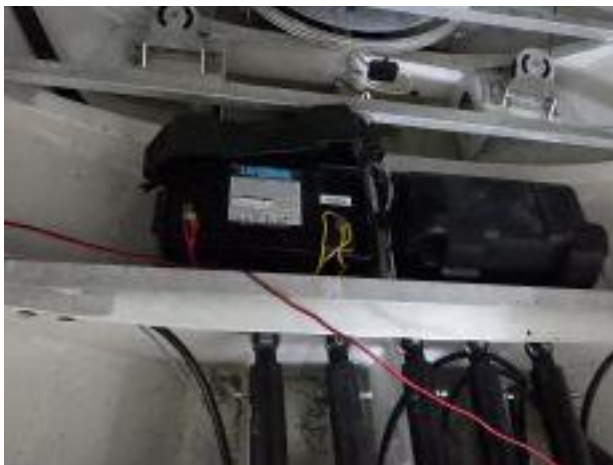
- 2 X Lifeline 12-volt 110 AH AGM sealed batteries
- Main breaker panel main salon with AC & DC

- Batteries are in secure acid proof boxes with tops
- Batteries have isolation switches
- All circuits protected with overcurrent devices
- Wiring is approved type well run and properly secured

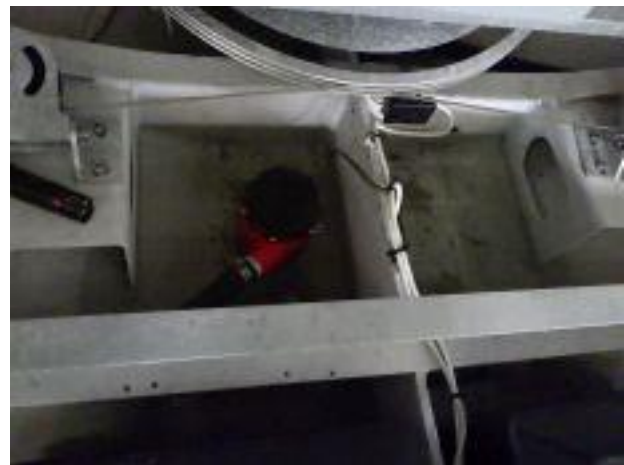
Bilge & pump fwd. of trim tab

- Bilges are all accessible and have a good limber system to the suction locations
- 2 X 12-Volt DC Johnson pumps – 2200 gal./hour each
- 2 X Edson manual diaphragm pumps

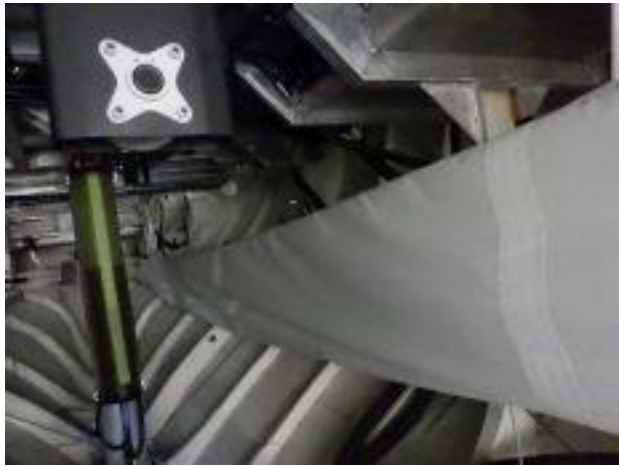
Hydraulic reservoir accumulator

- 1 x 'America's Cup' style pedestal powered rotary pump
- 3 X hand pumps in tailers cockpit and main sheet pedestal
- Head-stay ram is linked to a 10-L pressurized composite fluid reservoir and pressure transducer
