FILE NUMBER: 24595A

CHANTICLEER

SURVEY REPORT

MODEL: Raised Pilothouse Motor Yacht

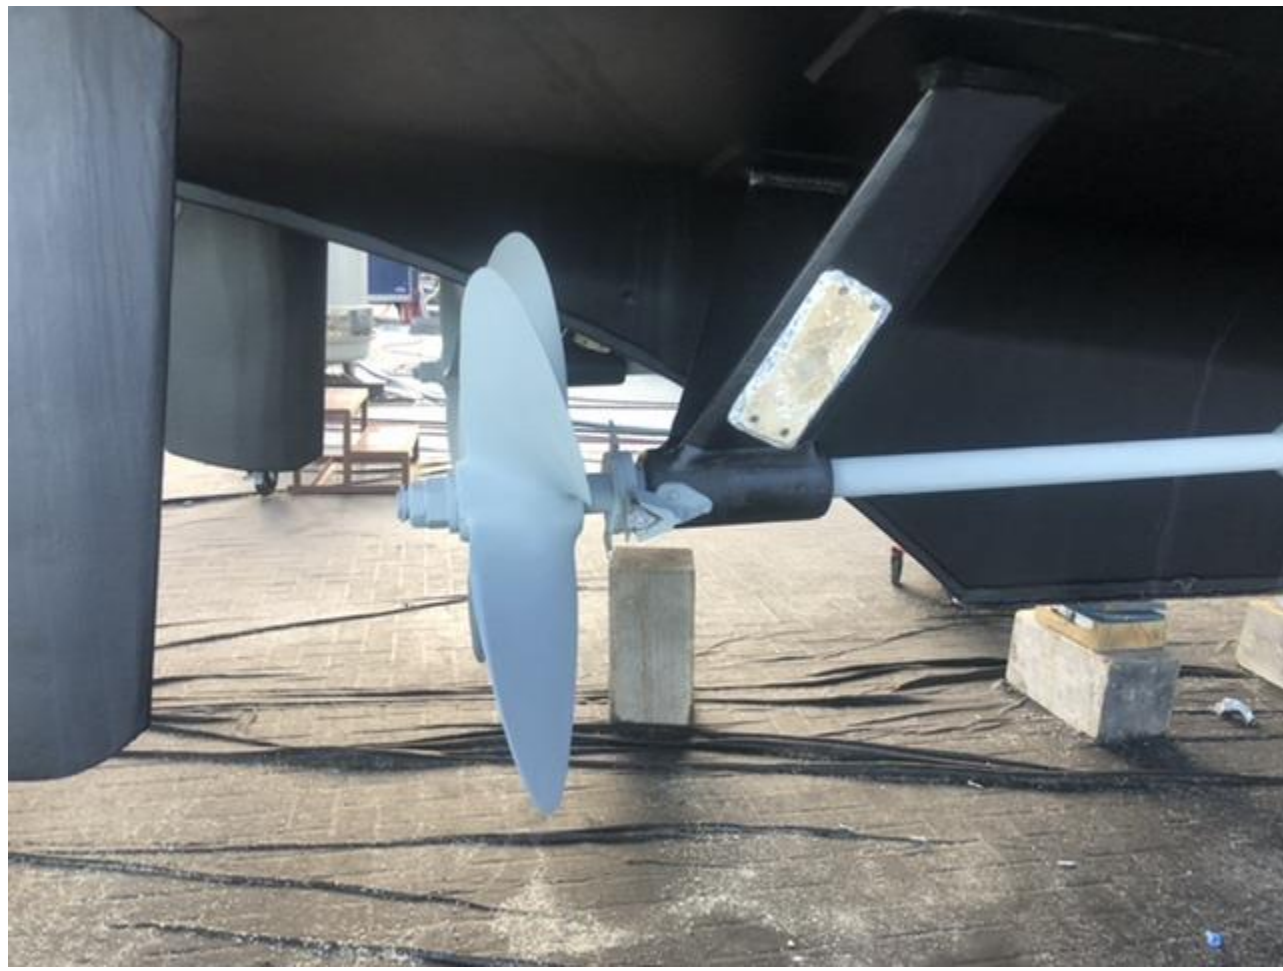
RUNNING GEAR

PROPELLERS: 4-bladed 40" x 40"

PROPELLER SHAFTS: 2 3/4" stainless steel **SPARE SHAFTS:** none **STUB SHAFTS:** yes

BEARINGS [SHAFT]: cutlass

STRUTS: single and double-arm each side

RUDDER: foil shaped 34" x 50"

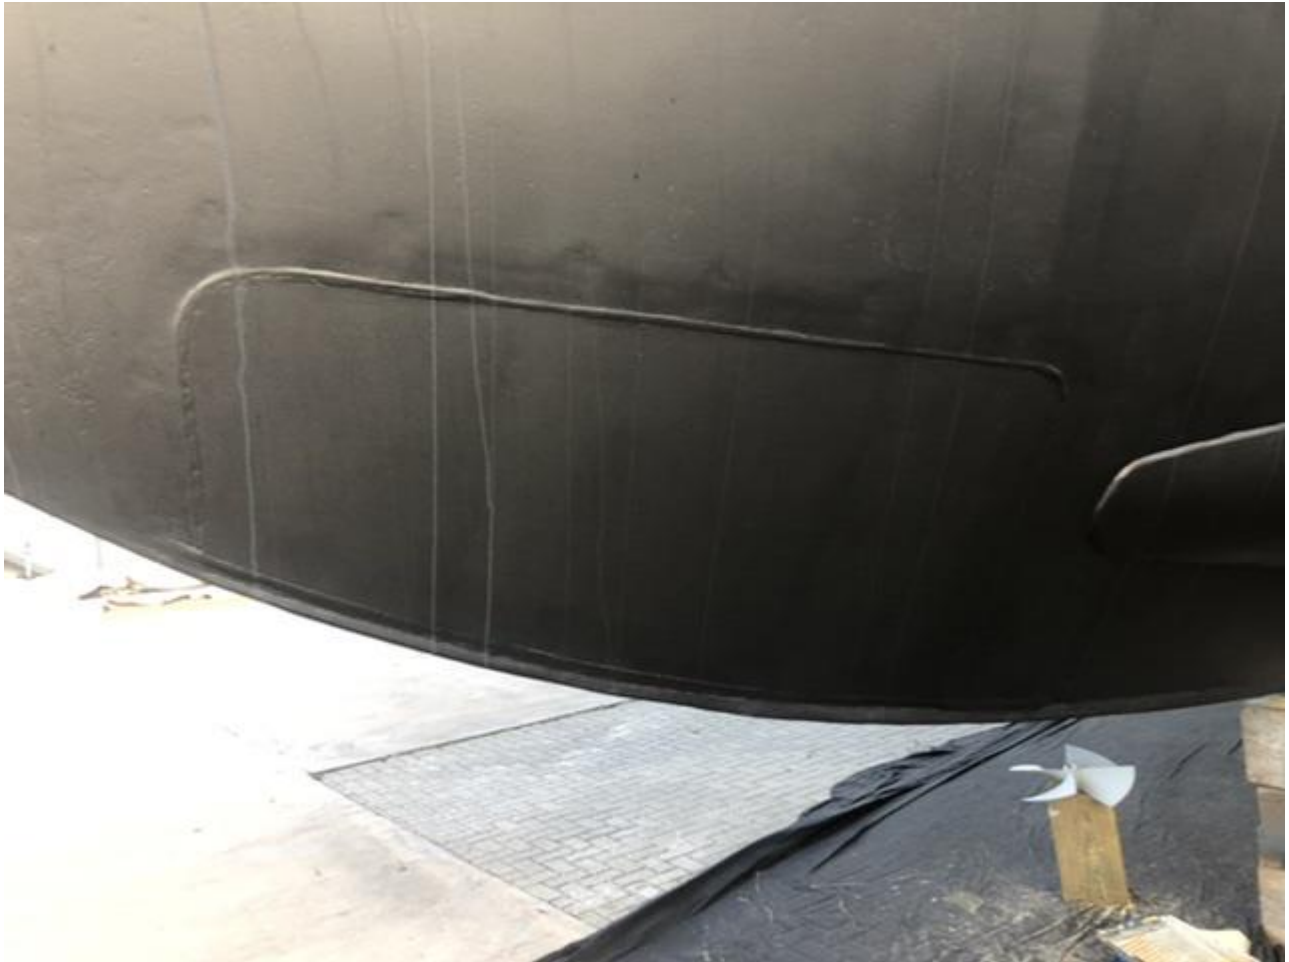
PREVIOUS SHELL PLATE REPLACEMENT FRESHWATER TANK
