REPORT OF MARINE SURVEY

PASSING WIND

1992 CARPENTER 62

October 3, 2022

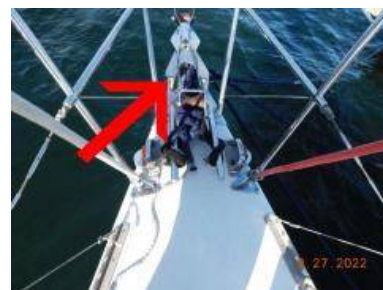
Anchor platform: Stainless steel with anchor roller. Well secured-no cracks sighted.

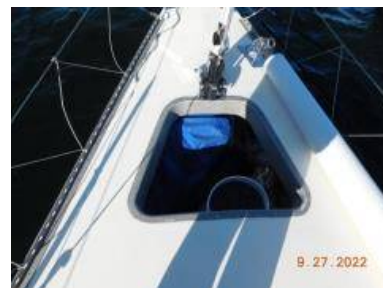
Anchor/chain locker: Yes accessed from top deck with hatch lock. Functional.

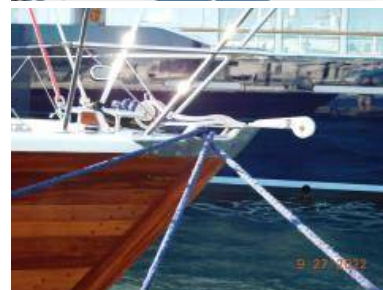
Bow pulpit/rail: Stainless steel with side rails, Well secured.

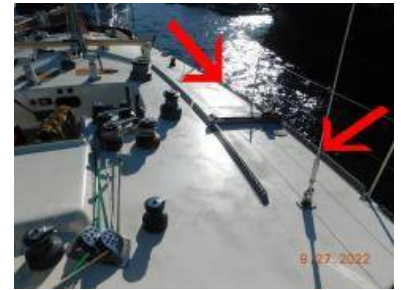
Toe rail(s): Slotted aluminum toe rails - well secured to deck.

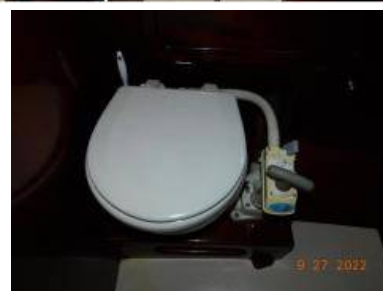
Toilet(s): Jabsco, Manual flush pump, Appeared functional when tested. No leaks sighted.

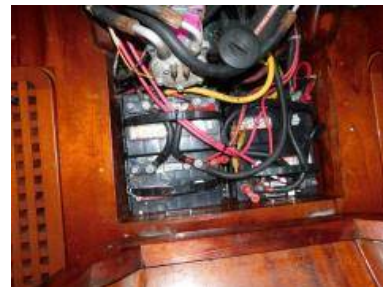
Primary batteries: There are four batteries located in the engine compartment that are, Group 24 Lead acid batteries which provide service to the house electric
Batteries are well secured with straps. Cables are properly color coded and positive terminals are properly covered with boots.

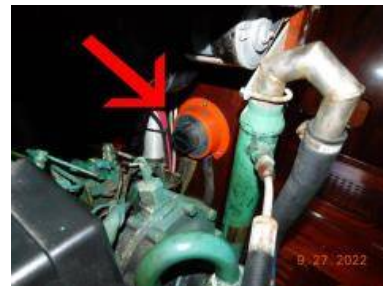
Battery selector switch: Yes Rotary switch is functional.

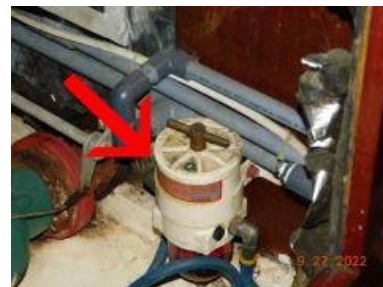
Fuel filter(s): Engine mounted, Racor water separator, fuel filter/water separator. Clear- No water sighted in lower bowl.

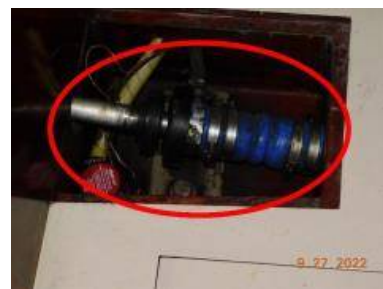
Stuffing box(es): Packless shaft seal system. Bellows and carbon collar is secure and appears functional.

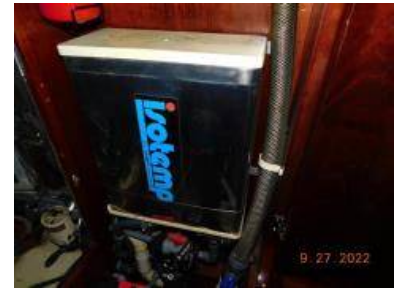
WATER HEATER

Tank location: Engine compartment.

Manufacturer/capacity: ISOTEMP.

How powered: 110V with heat exchanger coil.

Heat exchanger hoses: Heat exchanger hoses appear to be in good condition where sighted. No cracks or leaks sighted.

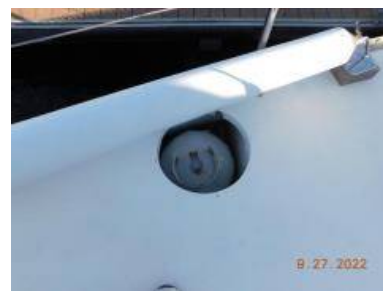
LPG (PROPANE) TANK(S)

No & location of tanks: One tank, Cockpit dedicated LPG locker with proper ventilation overboard.

Secured: Tank is properly secured to prevent upset or displacement that could place a strain on fuel distribution or appliance fittings per ABYC A-1 recommendations.

Tank type & OPD: Aluminum alloy Tank is properly fitted with the Overflow Protection Device (OPD)

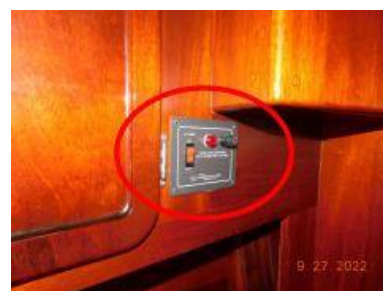
Shut off valve(s): LPG shut off valve at the tank top. In addition an LPG electrical solenoid shut off valve switch is available near the galley and is functional.

Supply lines: Flex LPG type hose. Good condition where could be sighted.

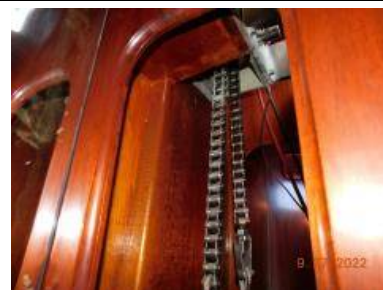
STEERING SYSTEM

Type: Custom Wheel steering, Chain and sprocket to stainless cable.

Pulley, cable, chain: Cable appeared to be in good condition - No broken cable wires sighted and cable pulley / sheaves are well secured. Keep this cable properly lubed and inspect steering often.

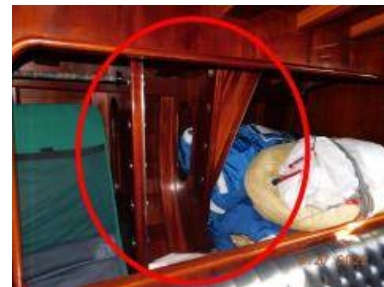
Chainplates: Chain plates well secured to deck, side hull and or bulkheads for portions that were visible..

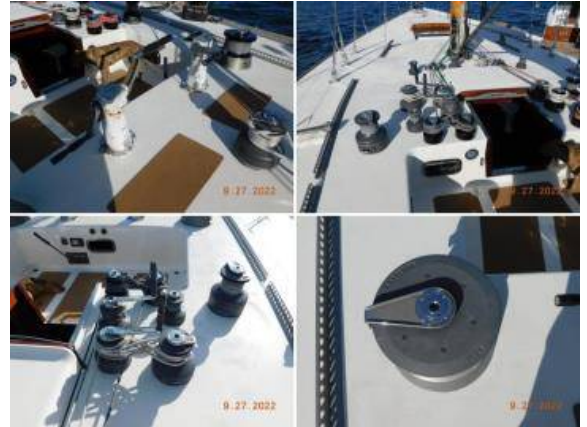
There are 24 Barient winches.
There is a set of coffee grinders.
All winches are functional and
are well conditioned.

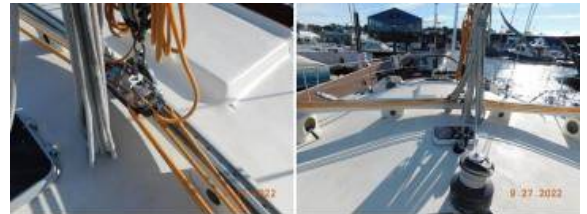
Traveler(s):

Blocks and track appear
serviceable and well secured.
Traveler car runs smoothly side to
side.

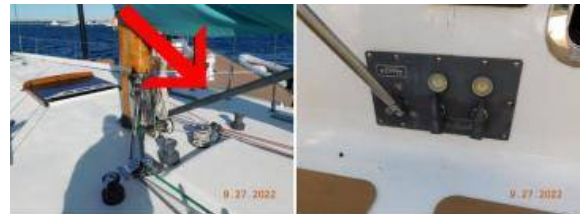
Boom Vang:

Navtec hydraulic.

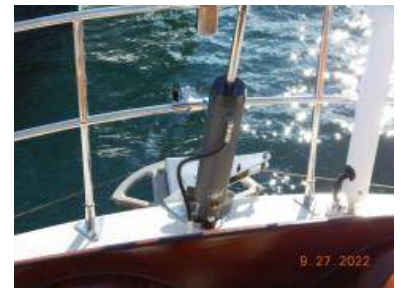
Backstay adjuster:

Navtec Hydraulic - appears serviceable.

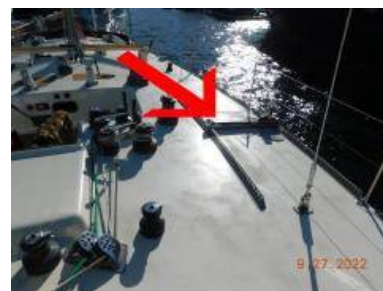
Genoa Sailtracks / Cars: Athwart ship tracks Securely mounted on both side decks.

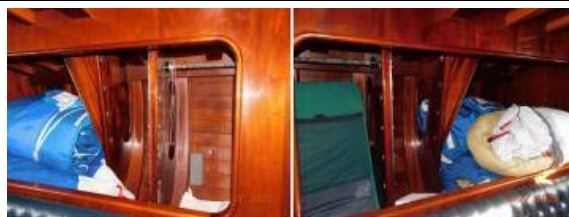
Sail inspection note: As with any racing program, there are multiple sails available. The mainsail is made by Hood and is reported to be made in 2022. The jib also is Hood and built in 2021.

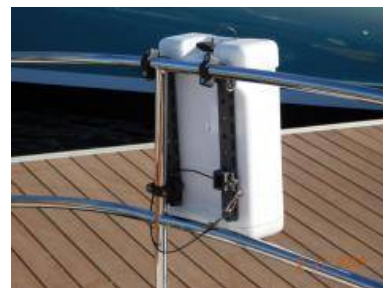
Throwable type PFD's: USCG approved Lifesling rescue system device, All Throwable PFD's sighted appear to be in good condition.

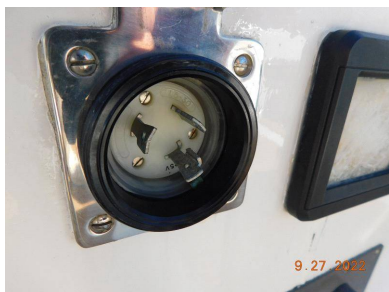
30 Amp - 120 Volt system. Shore Power: provided by Marinco 30 Amp capacity.

The cover is missing repair or replace.
