**REPORT OF MARINE SURVEY**

**Condition & Value  
of the vessel**

**PASSING WIND**

**1994 CARPENTER CUSTOM YACHTS 62**

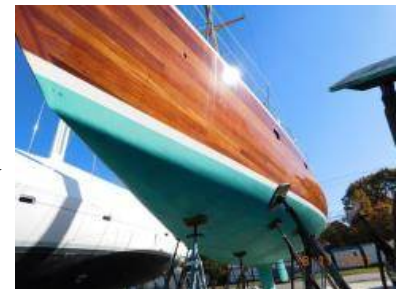
Due to the total refinishing of the exterior, there were no fasteners pulled. The mahogany planking showed no signs of paneling and the forward hood ends were smooth and undisturbed. The transom was smooth and fair. Due to the clear exterior finish none of the butt blocks showed signs of wear.

**Hull cosmetics:** The hull was stripped to bare wood and re-painted with clear coat.

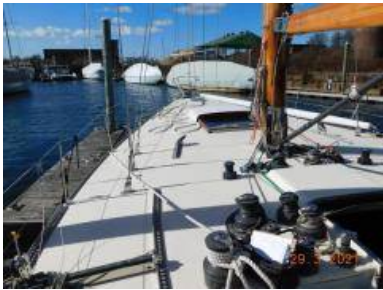
**Deck Surface:** Cold Molded, with fiberglass covering deck construction.

**Moisture/Delamination:** Moisture meter readings not taken due to wet deck surface. No apparent delamination when checking top deck with phenolic percussion hammer.

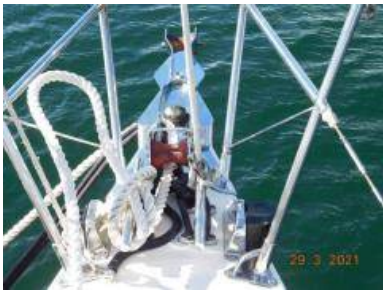
**Anchor platform:** Stainless steel with anchor roller. Well secured-no cracks sighted.

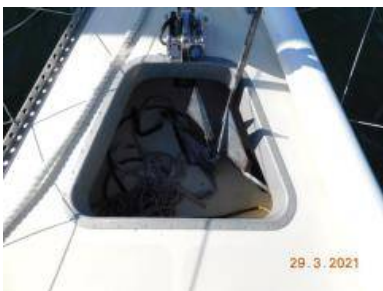
**Anchor/chain locker:** Yes accessed from top deck with hatch lock. Functional.

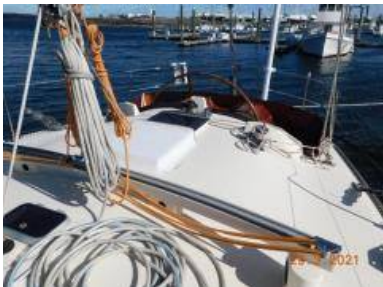
**Exterior teak:** Exterior wood is Mahogany and it is in excellent condition.

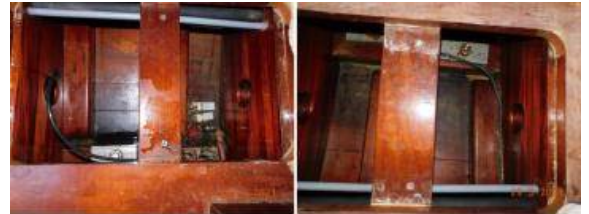
**Bilge(s):** Clean and dry.

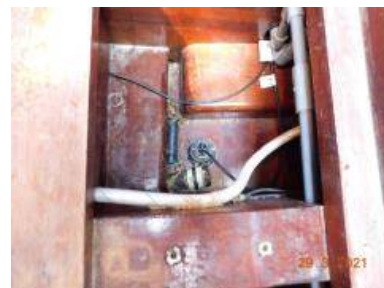
**Transducers:** Speed & Depth transducers are adequately sealed.  
No leakage sighted inside hull.

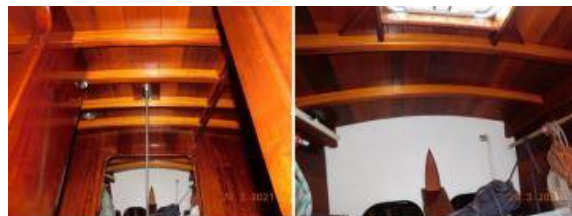
**Headliner:** Wood paneled. Clean and well fastened.

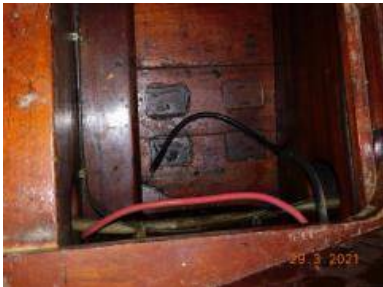
**Battery Set Two:** There is one battery located in the engine compartment that is a Group 27 Lead acid which provide service to the engine. This battery was removed at time of survey.

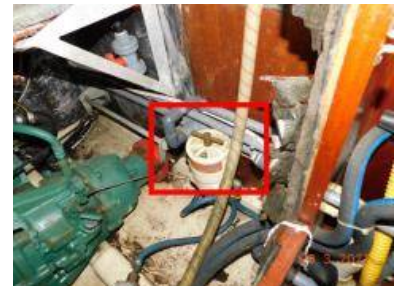
**Fuel filter(s):** Engine mounted, Racor water separator, fuel filter/water separator. Clear- No water sighted in lower bowl.

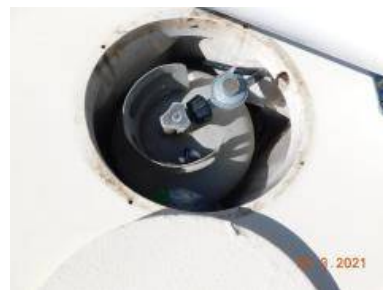
**No & location of tanks:** One tank, Cockpit dedicated LPG locker with proper ventilation overboard.

**Secured:** Tank is properly secured to prevent upset or displacement that could place a strain on fuel distribution or appliance fittings per ABYC A-1 recommendations.

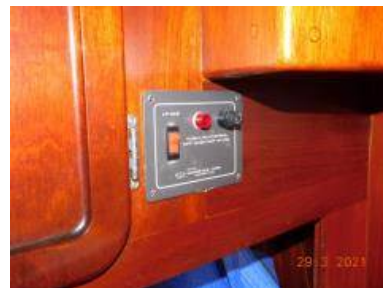
**Shut off valve(s):** LPG shut off valve at the tank top. In addition an LPG electrical solenoid shut off valve switch is available near the galley and is functional.

**Supply lines:** Flex LPG type hose. Good condition where could be sighted.

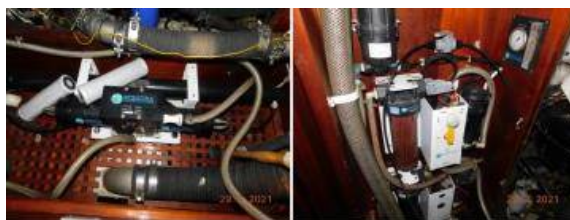
**Manufacturer:** Spectra Watermaker.

**Secured:** Yes.  
**Location:** Engine room.  
**Inspection/cleaning access:** Good.  
**Water supply lines:** PVC.  
**Through-hull(s):** Bronze mushroom thru hull.  
**Sea valve(s):** Bronze sea valve Operational.  
**Ignition protected:** Yes.

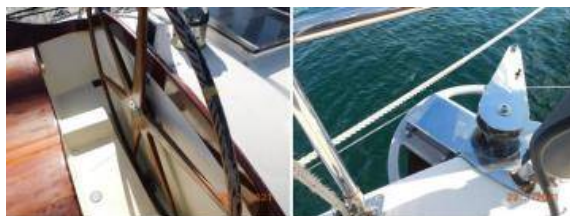
**Type:** Cockpit Wheel steering, Pedestal mounted cable type radial quadrant drive at rudder head.

**Lines and fittings:** Flex cable lines.  
**Pulley, cable, chain:** Cable appeared to be in good condition - No broken cable wires sighted and cable pulley / sheaves are well secured. Keep this cable properly lubed and inspect steering often.  
**Mounting(s):** Secure with stops in place.  
**Rudder stock(s):** Visually sound.  
**Emergency tiller:** Emergency tiller is available and appears functional.

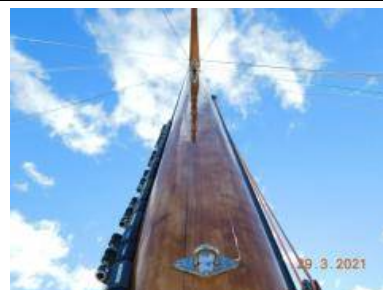
**Main mast(s):** wood, Sitka spruce. Good condition. No cracks or rotted areas sighted. Wood is varnished for protection from elements.

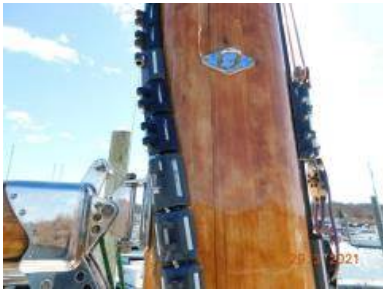
**Mast track(s):** Mast sail track appears serviceable.

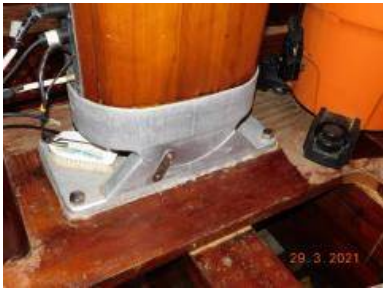
**Main mast step:** Keel stepped mast. Mast step is in good condition..

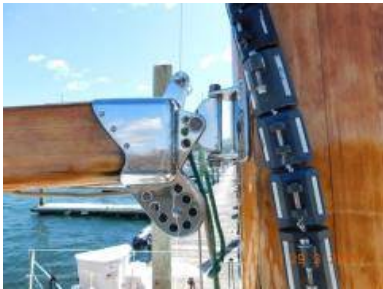
**Gooseneck(s):** Stainless steel - Well secured and no signs of abnormal wear.

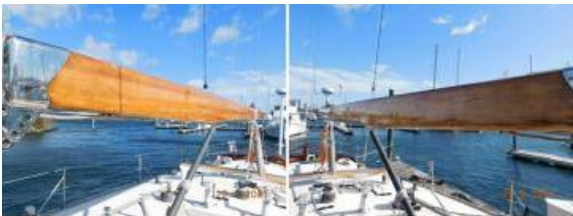
**Boom(s):** Sitka spruce booms for main mast in excellent condition. Boom bails and cleats are well secured.

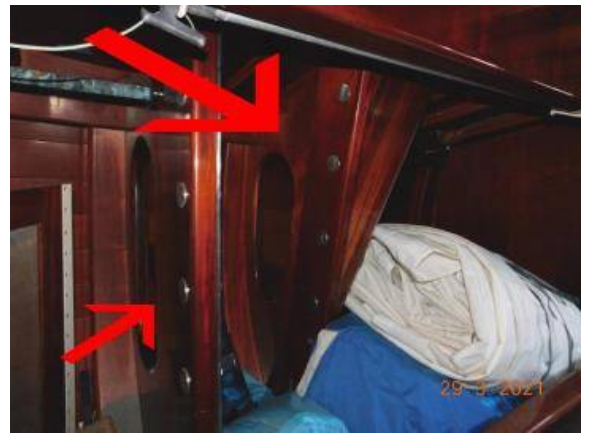
**Ends:** Secure and no split or corroded ends/wires.  
**Turnbuckles:** Stainless steel closed barrel design .  
**Chainplates:** Chain plates well secured to deck, side hull and or bulkheads for portions that were visible..

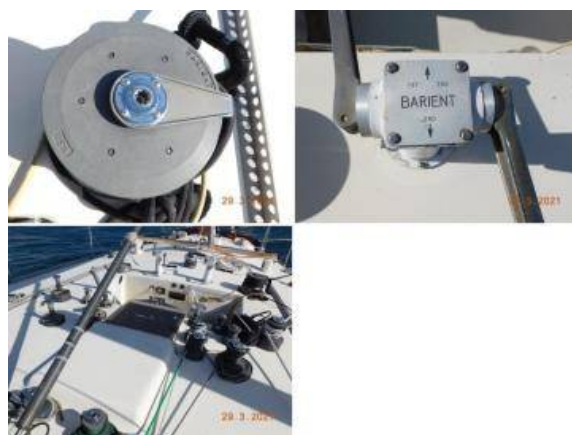
There are 26 winches in the cockpit. They are all being serviced. The winches are made by Barient, Lewmar and Harken.

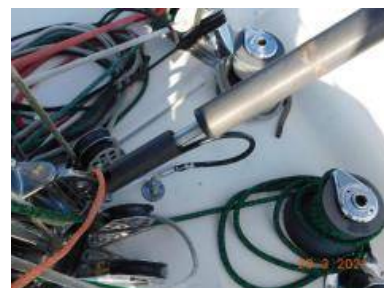
Hydraulic controlled rigid boom vang. Well secured and appears functional.

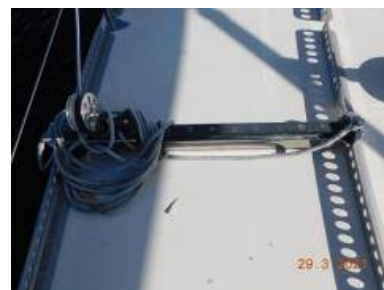
Securely mounted on both side decks.
