# Pantropic Power TA1 Marine Engine Inspection Form

Inspection Number	21435104	Customer No	2974218576
Serial Number	RPM01139	Customer Name	MV IONIAN PRINCESS
Make	CATERPILLAR	Completed On	2/26/2025 1:16:02 PM
Model	C32	Inspector	Alex Seda
Equipment Family	ENGINE - MARINE	PDF Generated On	2/26/2025
Asset ID	Port	SMU	139 Hours
Location	1601 SW 20th St, Fort Lauderdale, FL	Coordinates	4.17741110228122, -26.0980227446999, -80.1636510558572

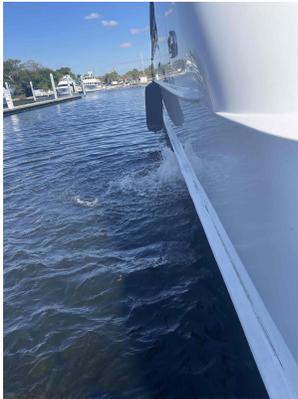
1.3 Observe engine exhaust colors and sheen on water.

Comments: No signs of smoke or sheen in water.

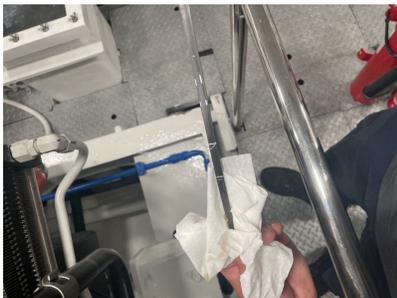
2.1 Engine Oil Level

Comments: Dipstick showing full. Customer recently changed oil.

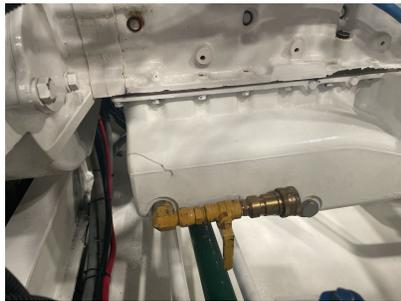
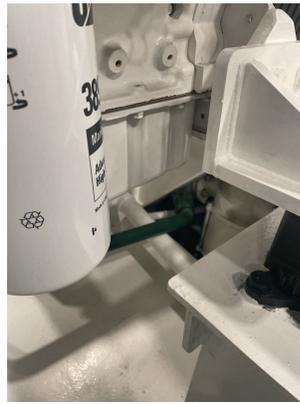
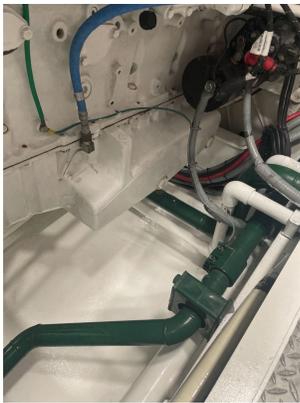
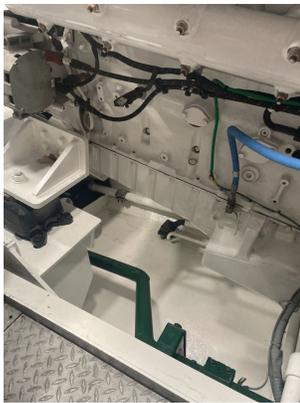
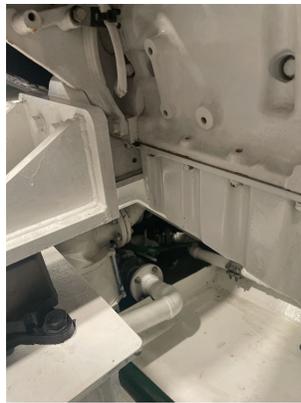
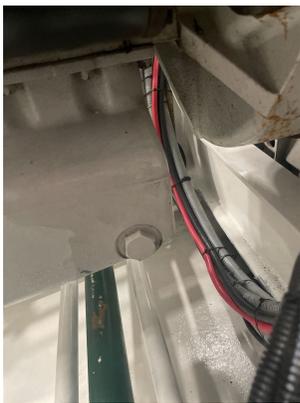
● 2.3 Engine Oil Pan

Comments: No sign of leaks.

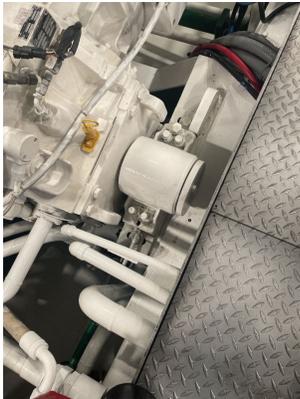
**Image Comment(s):**Inboard transmission mount.

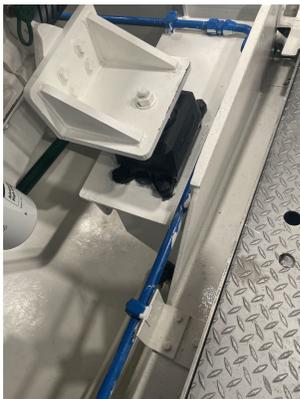
**Image Comment(s):**Inboard transmission mount.

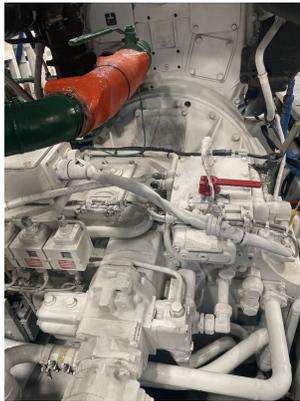
Image Comment(s):Inboard side. Image Comment(s):Rear.

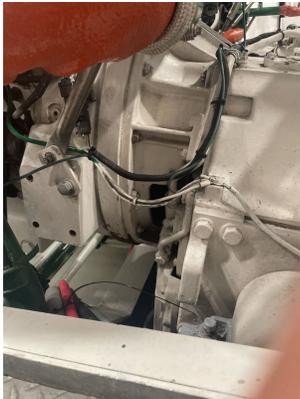
Image Comment(s):Outboard side.

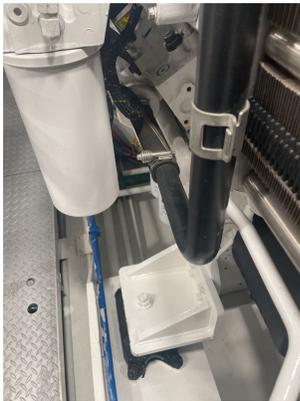
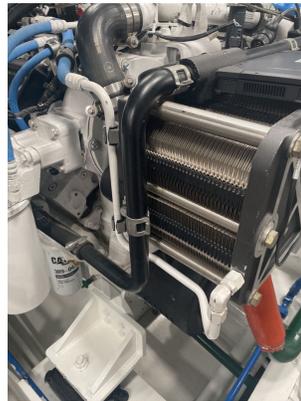
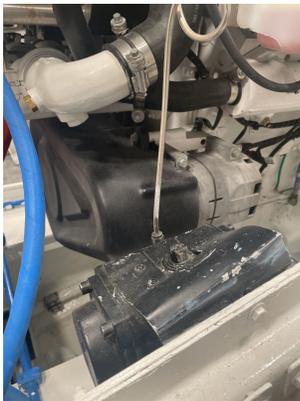
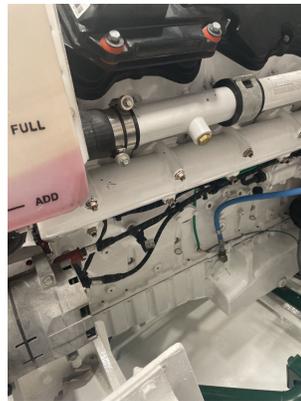
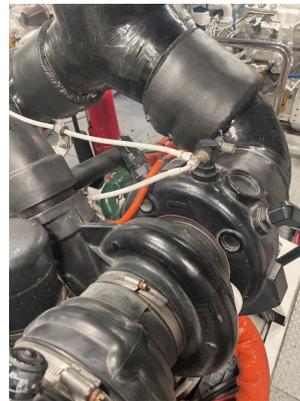
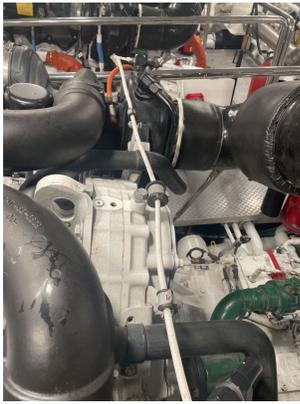
● 3.5 Water Hoses / Lines

NORMAL

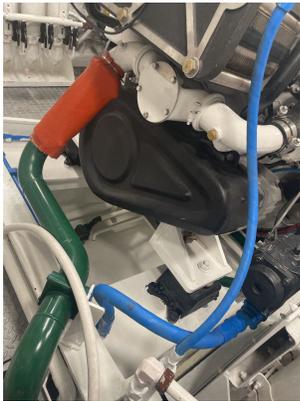
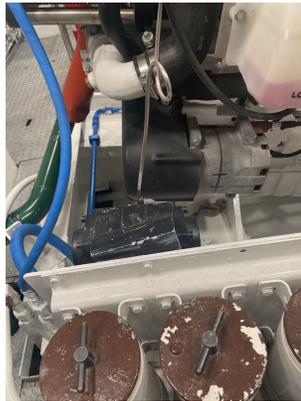
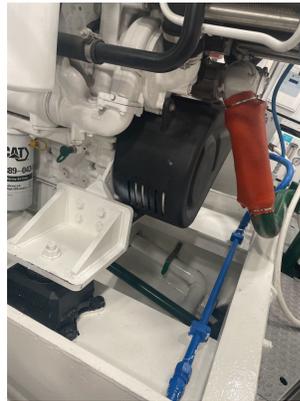
● 3.6 Belt Guards

NORMAL

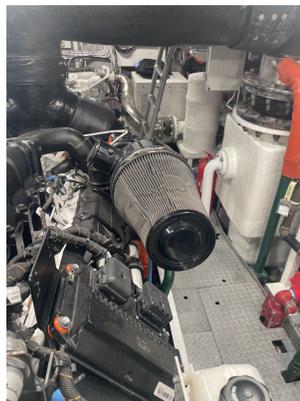
● 4.1 Air Cleaner and Precleaner

NORMAL

Image Comment(s):Inboard side. Image Comment(s):Outboard side.

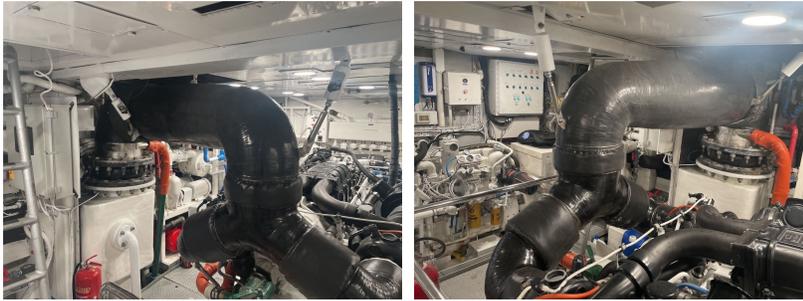
● 4.2 Air & Exhaust Lines

NORMAL

Image Comment(s):Rear.

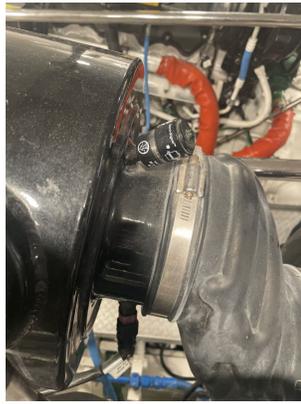
● 4.4 Air Restriction Indicator

NORMAL

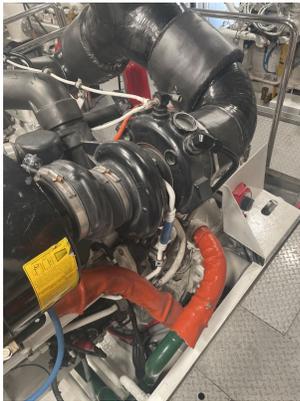
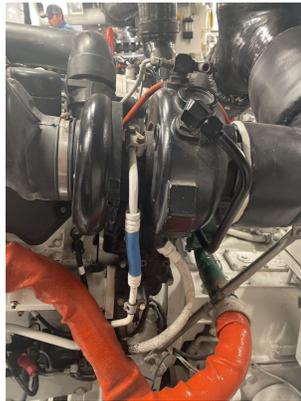
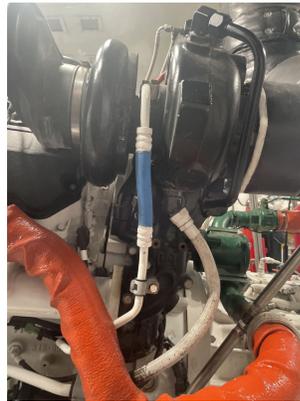
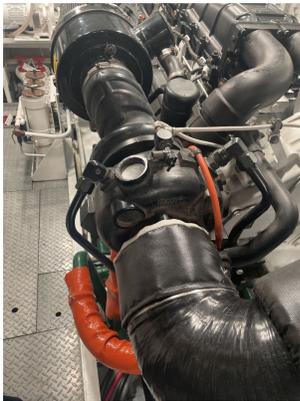
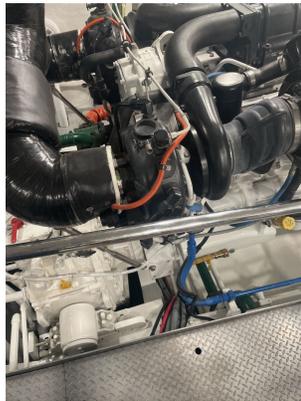
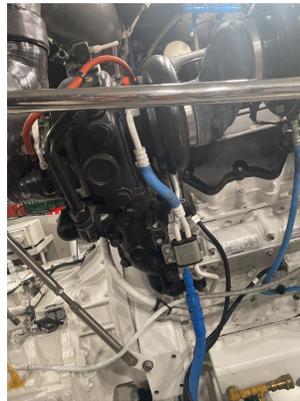
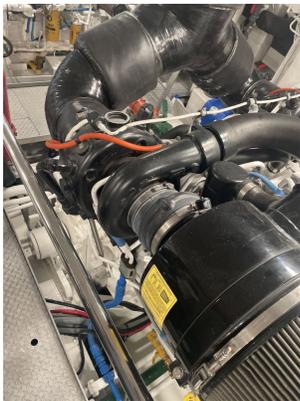
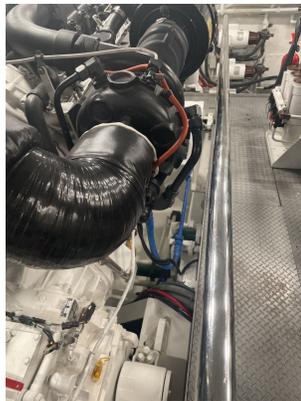
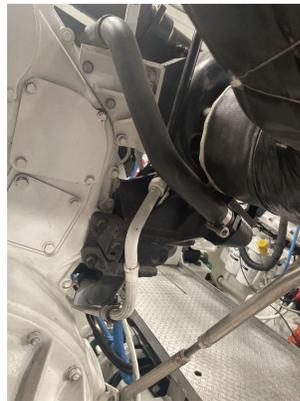
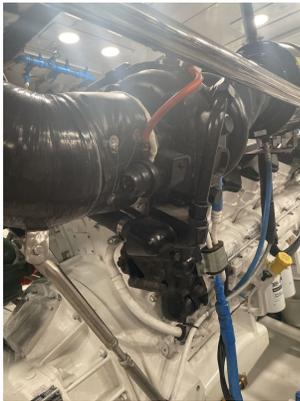
● 4.5 Turbocharger(s)

NORMAL

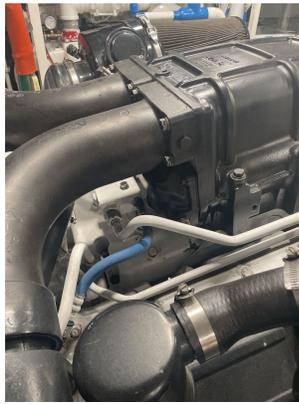
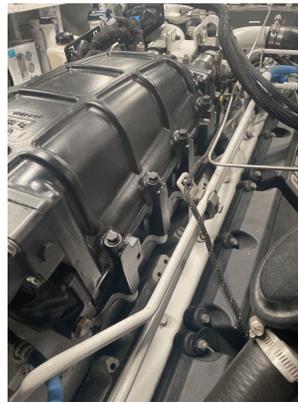
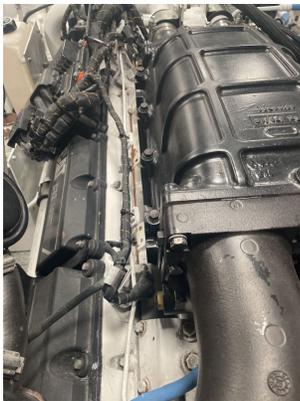
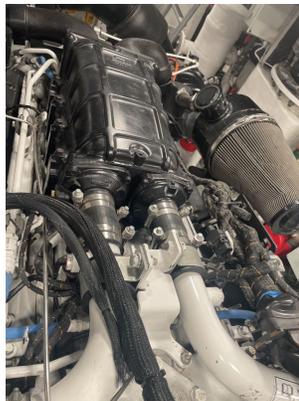
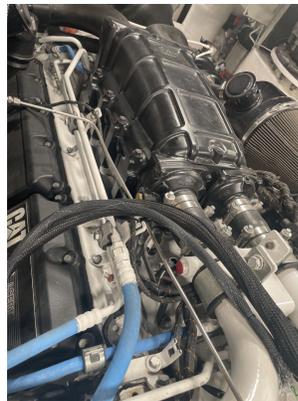
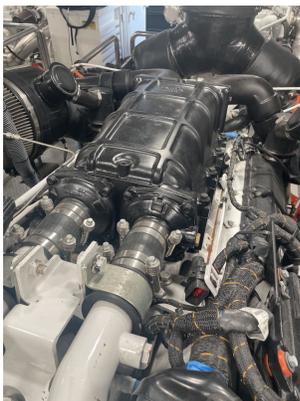
● 4.6 Aftercooler Housing(s) & Core(s)

NORMAL

Comments: No signs of leaks.

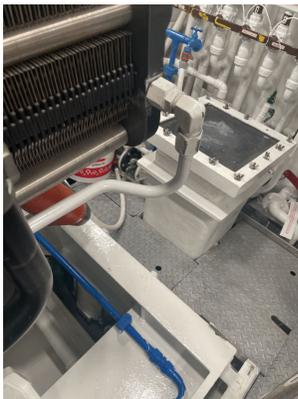
5.1 Fuel Lines, Fuel Pump and Fuel Filter Base

NORMAL

Image Comment(s): Transfer pump.

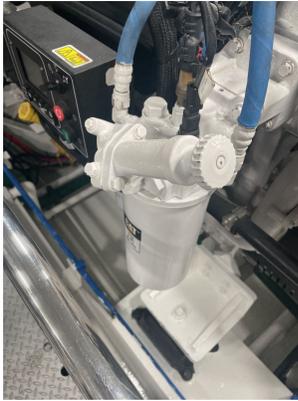
● 5.2 Fuel Priming Pump

NORMAL

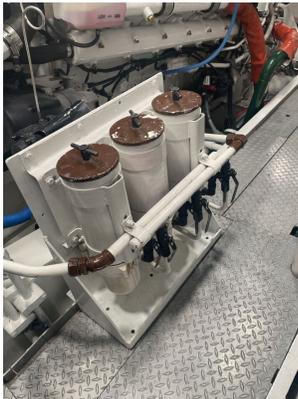
● 5.4 Water Separator(s)

NORMAL
