**CONDITION AND VALUATION REPORT FOR PRE
PURCHASE PURPOSES**

NAME OF VESSEL "TA-BOO" 1970 Rybovich 54' Sport Fisherman			
FILE NO. 062725			
SURVEY REQUESTED BY Dale Matteson P.O. Box 981, Palm Beach, Florida 33480			
UNDERWRITER OR INSURANCE COMPANY Unknown			
CONTACT Dale Matteson 702 592 4200			
OWNER Dale Matteson			
MASTER Same			
SURVEY DATE 02/27/2025, 06/25/2025, and 06/27/2025		DATE OF THIS REPORT 06/27/2025	
DOCUMENTED NO. 524622	STATE REG. NO. N/A	REG. PORT Ocean Reef, Fl.	
USE Pleasure			
LOA: 54'	LWL	BEAM: 15'6"	DRAFT: Per 3'6" Reported
G.T. 40 GRT Per document	N.T. 32NRT Per document	SPEED 20.8 Knots Cruise at sea trial	
HULL NO. 72 Reported/ No Hull ID		ENGINES Two Mann 2848LE403's 800 HP reported with ZF transmissions	
HULL MATERIAL / CONSTRUCTION Cold Molded Wood/Fiberglass			
WHERE PURCHASED Unknown			
ORIGINAL PURCHASE PRICE UNKNOWN			
DATE LAST HAULED February 2025 Cracker Boy Boat Works, Riviera Beach, Florida			
DATE OF PRESENT HAULING, IF APPLICABLE Same/ Survey was performed in water on 6/20/25 and the haul out February 2025

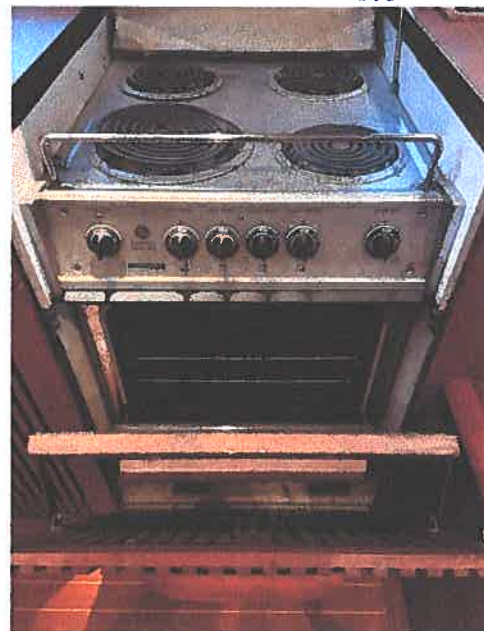
Stove Lots of
CORROSION *

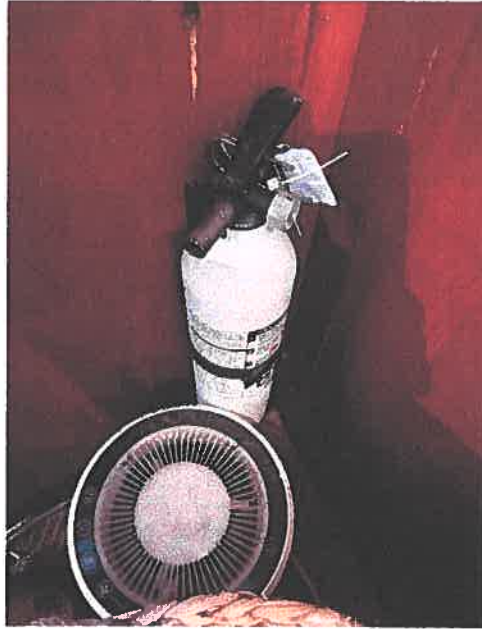
Fire Extinguishers			
Number	Type	Location	Date Inspected
4	Dry chemical	Various locations	2022*
2	Carbon Dioxide	Engine room	2022*
PFDS 12 noted Type 1&2		One throwable type IV, need lanyard*	
Water Lights			
No			
Flares			
Orion signal kit (2020) Needs replacing*			
Epirbs			
No			
First Aid Kit			
Yes/Older/Replace with new*

NEED INSPECTION & TAGGED
EXPIRED FIRE EXTINGUISHERS *

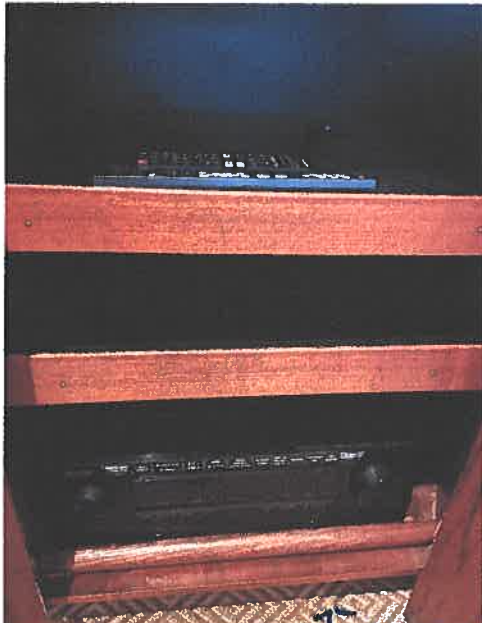
STEREO NEEDS PROVEN

21. Both TV's and stereo inside need to be proven. Could not get to work. Replace it if needed.

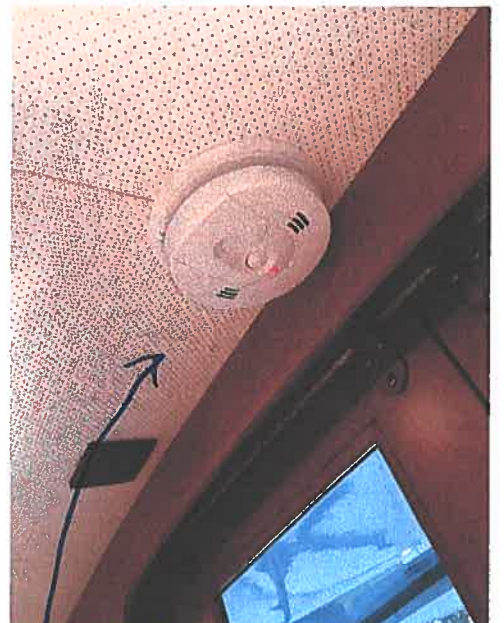
SALON SMOKE ALARM

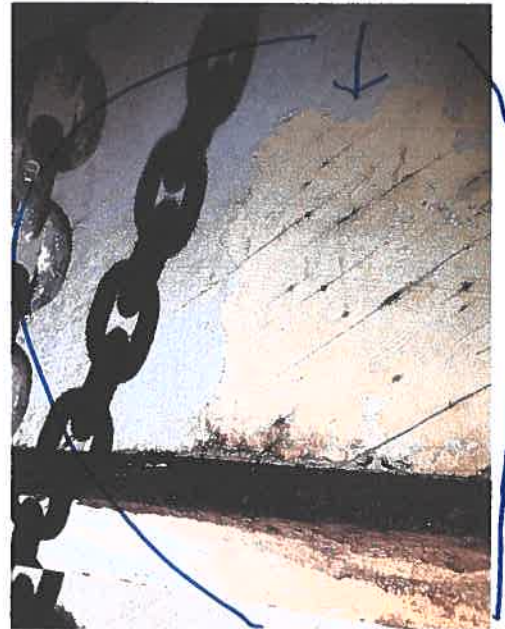
FORWARD PLANKING AROUND STEM

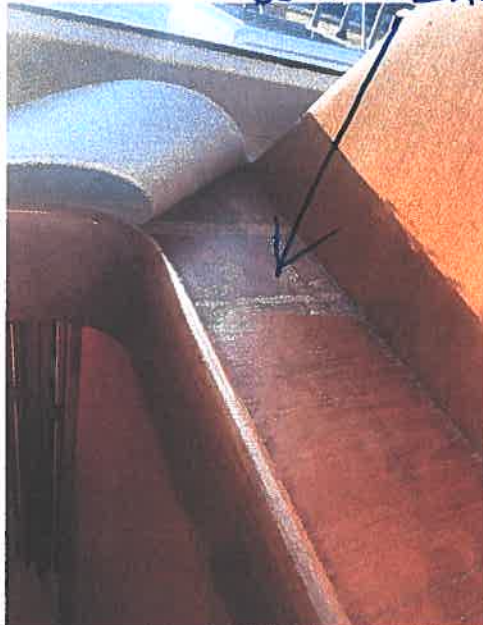
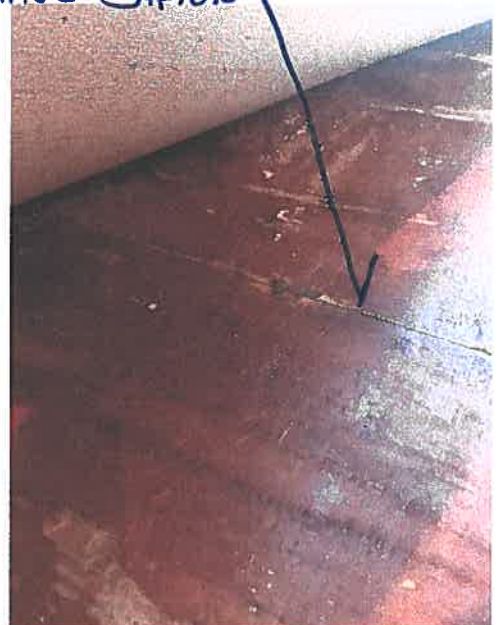
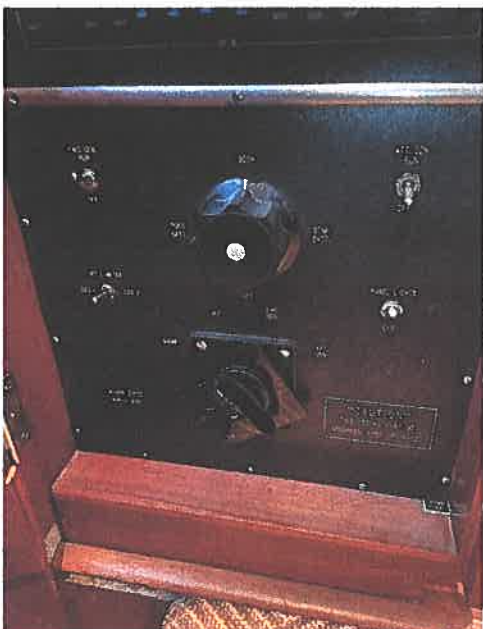
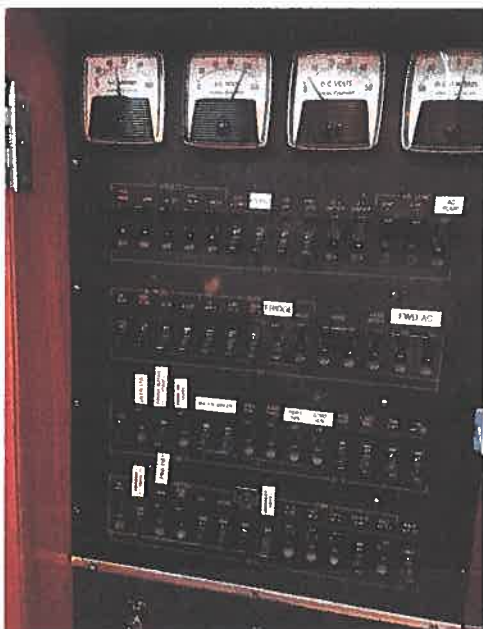
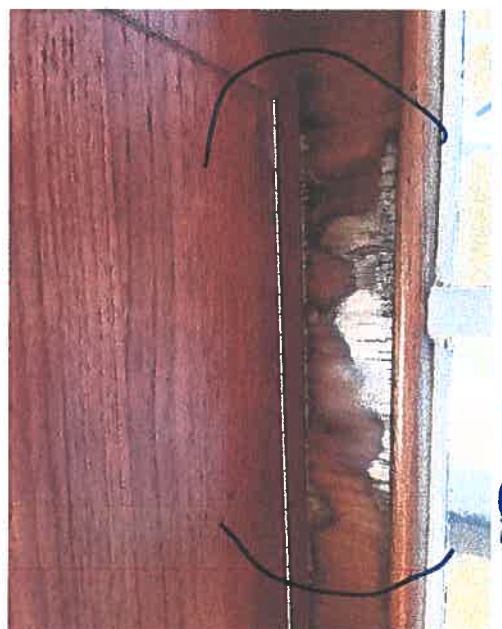
WATER DAMAGE SALON

WATER DAMAGE
SALON *

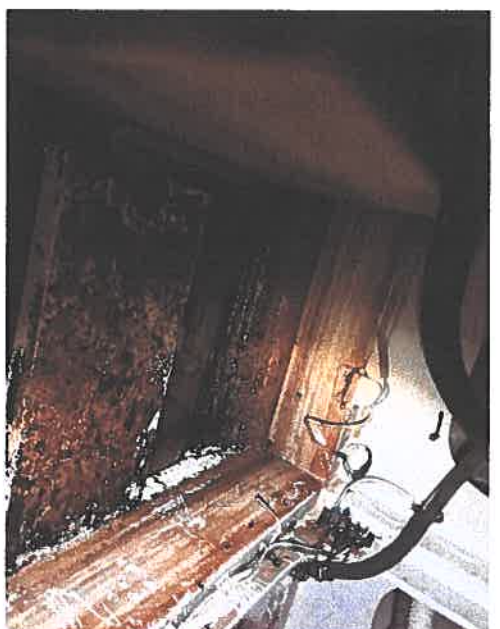
Need Further Inspection

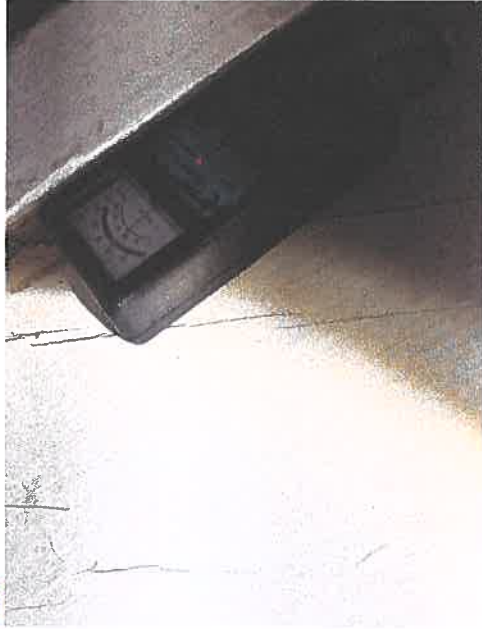
Need Fastener

Currently the vessel's overall risk is FAIR. It's the Undersigned Surveyor's Opinion that the vessel needs additional inspections for the vessel to be considered structurally sound, taking fastener samples throughout the vessel's hull, bottom and keel or destructive testing to determine if there are any electrolysis and or stringer support issues to support the surveyor's concerns that the vessel may have some structural electrolysis issues because of fasteners or lack of. With the recommendations completed the overall risk could be upgraded to AVERAGE if the hull and bottom fasteners are proven not to have issues and the longitudinal stringers are sound.

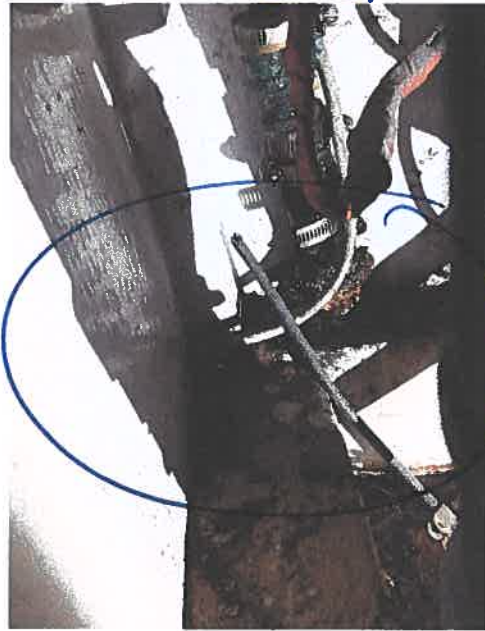
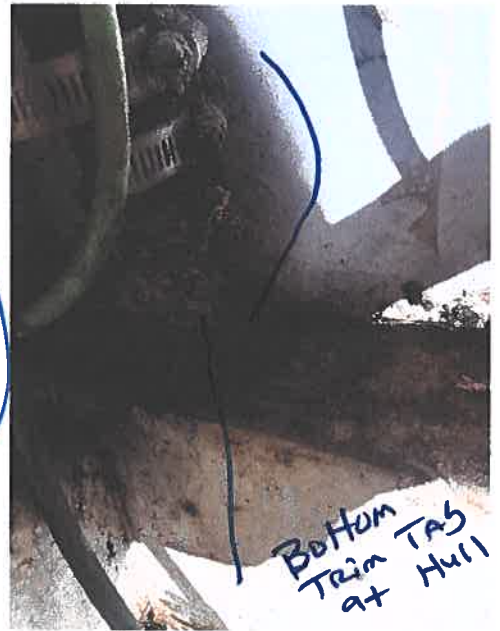
BROKEN BONDING WIRE

FROM THE HULL + INSIDE
NEEDS EXTENSIVE INSPECTIONS *

Check out of the water

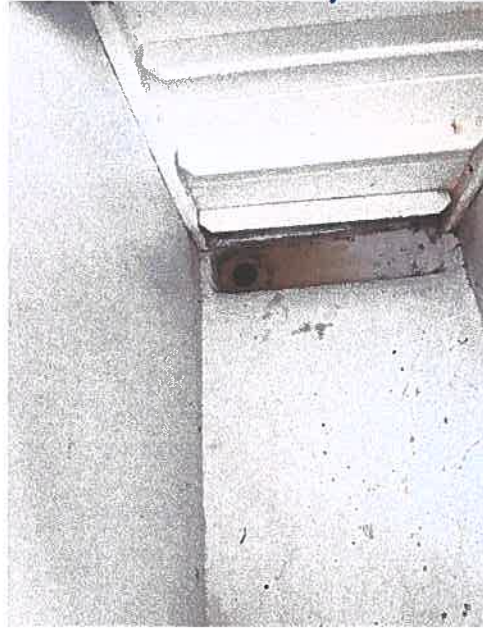
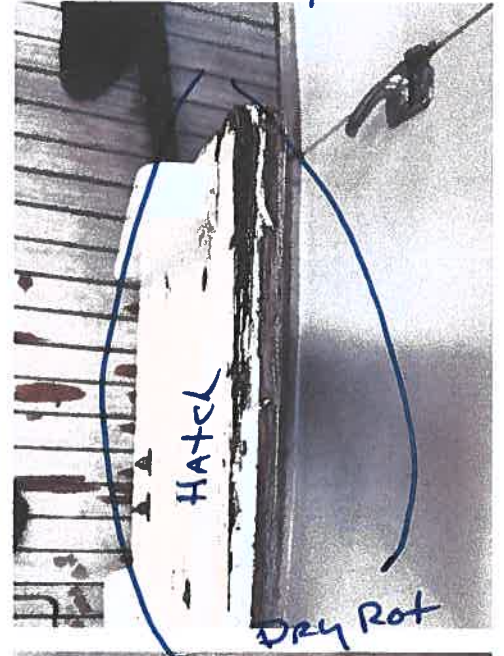
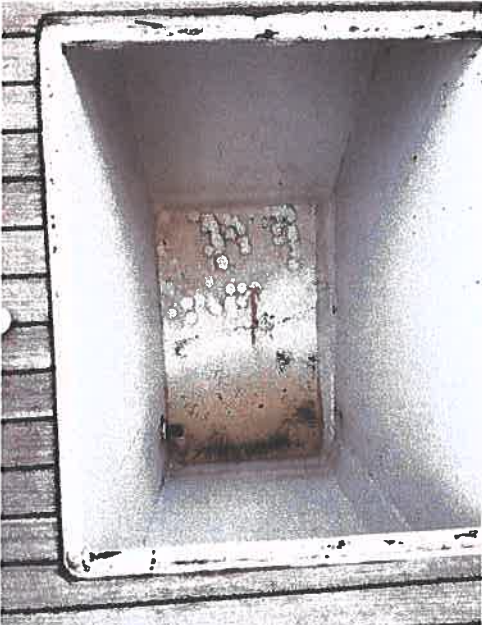
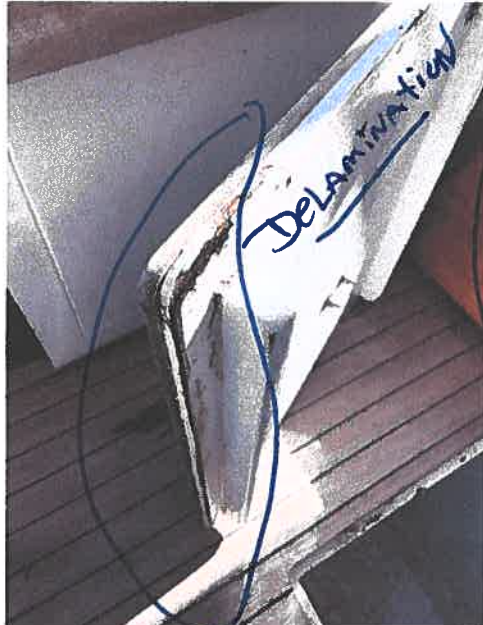
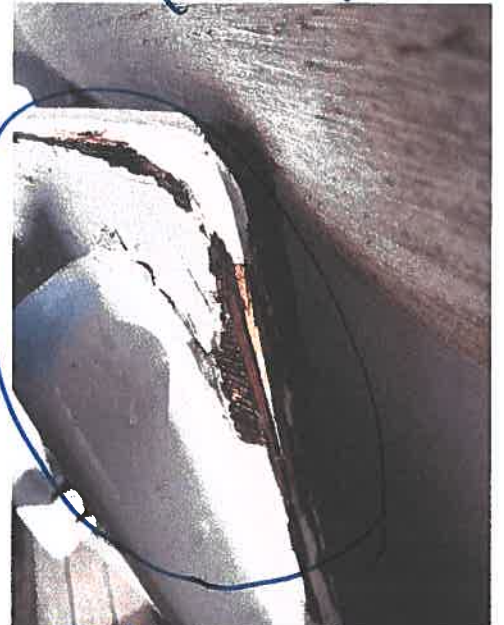
Dry Rot

Aft Deck Compartments AND Dry Rot *
